May 2, 2024

RE: Building Enclosure Assessment

Lifeguard Headquarters
Jacksonville Beach, Florida

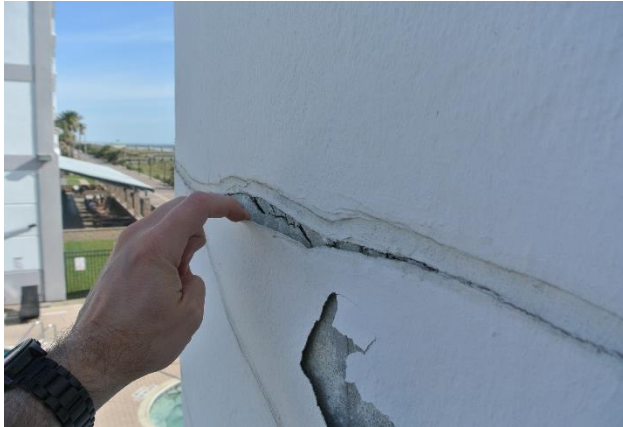
- The stucco is generally well adhered based on visual observation and sounding with a hammer. A few locations exhibited evidence of delamination which also corresponded to cracked and distressed areas (Figures 2 and 3).
 - At the southeast corner, a piece of loose stucco was removed below the soffit (Figure 4). The lath within the stucco was heavily corroded (Figure 5).

Figure 2. The coating on the stucco is peeling. The underlying stucco is cracked and delaminated.

Elsewhere, the stucco coating should be removed so that cracks can be routed and sealed and delaminated stucco removed and replaced.

Subsequent to these repairs as well as the window scope outlined next, the stucco should be recoated with a vapor permeable coating.

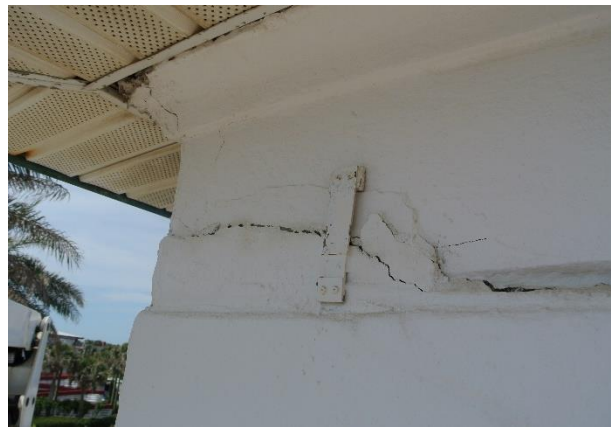
Figure 3. A sizeable crack with discernable displacement exists at the southeast corner.

At the southeast corner of the building, the stucco should be removed to fully review the underlying masonry. Upon this review, a rebuild or reinforcement repair will be necessary.

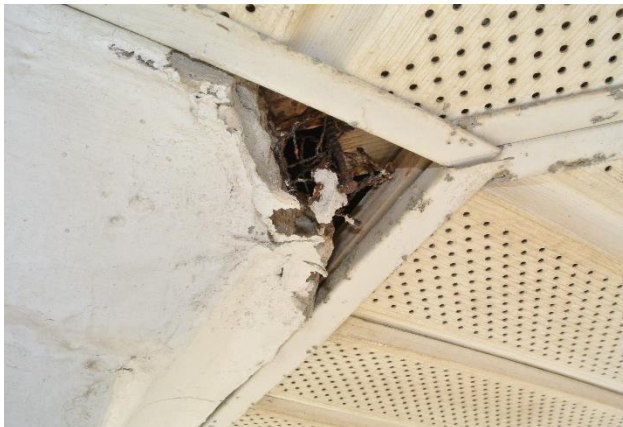
Figure 4. A small piece of ornamental stucco was loose and removed at the southeast corner.

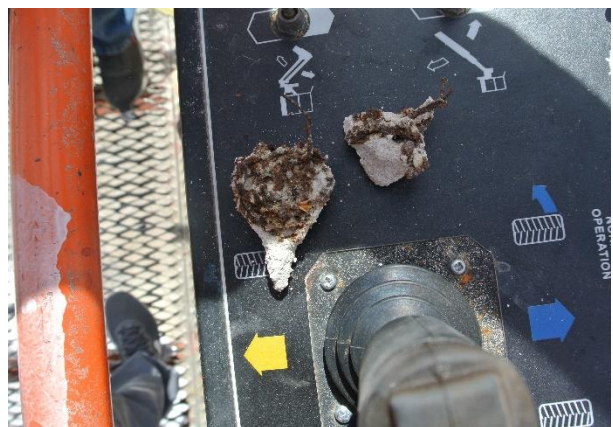
Figure 5. The removed pieces exhibit heavily corroded lath.

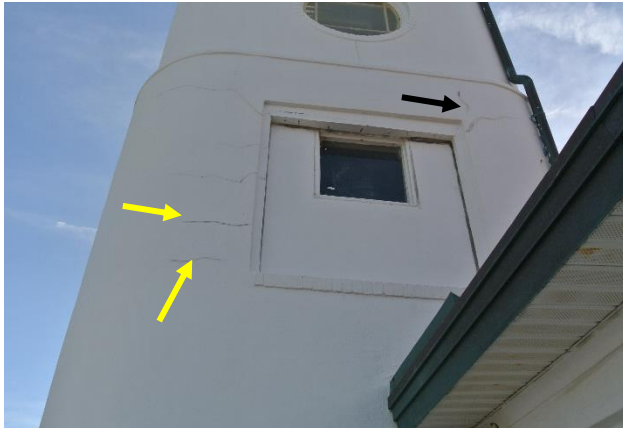
- Most cracking exists on the watch tower. The cracks either exhibit a radial (horizontal) pattern at the rounded corners of the tower or diagonal/stepped that originate at the window heads (Figures 6 and 7).
 - The rounded corners are laid with header units (Figure 8).
 - Previous concrete repair work is evident within the watch tower (Figure 9).

Figure 6. Radial cracks (yellow arrows) and diagonal cracks (black arrow) emanate from the window openings.

Over time and currently, the advanced state of distress observed in the stucco and brick masonry around window and door openings and within the field of the wall is generally caused by the expansive corrosion of embedded steel lintels and structural steel framing, respectively. Corrosion is an electrochemical process requiring an anode, cathode, and electrolyte. In this case, moisture absorbed by the masonry acts as the electrolyte with the embedded steel behaving as both the anode and cathode. When combined, the reaction results in a significant increase in the base metal volume as the ferrous component of the steel oxidizes into iron oxide, or rust which places pressure on the adjacent masonry leading to distress. When rust is present, the increased porosity of the steel surface tends to trap moisture and further accelerate corrosion. The rate of oxidation and deterioration of the steel lintels will accelerate if it is not arrested.

Most of the stucco repairs are isolated to the east facade and watch tower. Here, the stucco coating should be removed, stucco cracks routed and sealed, and delaminated stucco removed and replaced. At tower windows, the steel lintels should be removed where the window has been removed and infilled with masonry. Where a window remains, the lintels should be removed and replaced with a stainless steel lintel or a masonry lintel/arch.

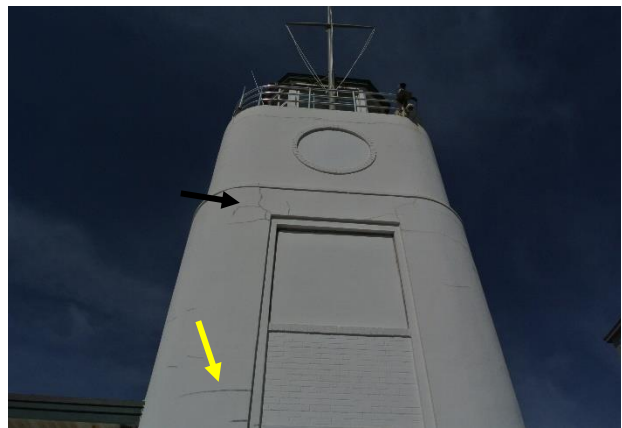
Figure 7. Radial cracks (yellow arrow) and diagonal cracks (black arrow) emanate from the window openings.

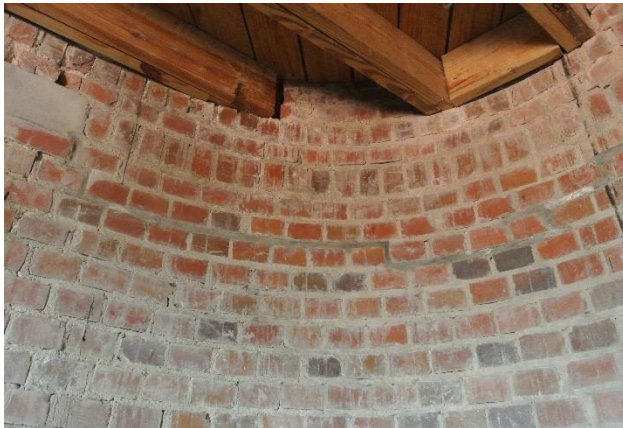
Figure 8. The interior brick wythe is exposed showing header units exclusively at the radiused corners.

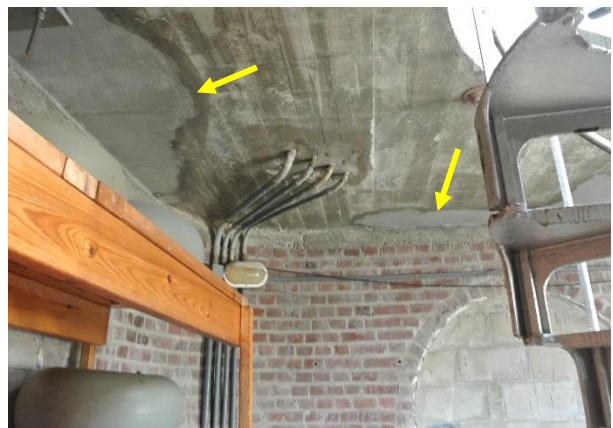
Figure 9. Previous repairs to the concrete floor slab and window headers were noted (yellow arrows).

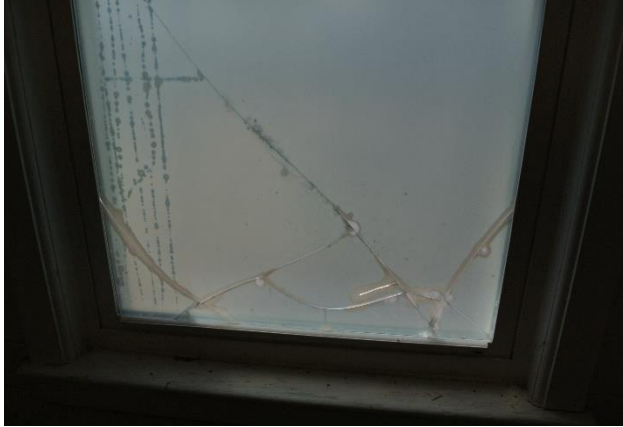
Figure 10. A few windows are broken.

While some units are broken or the IGU seal is breached, the vinyl residential casement windows are likely not rated to handle the coastal environment routinely experienced at this building.

The use of a residential style, casement window in a coastal environment will not provide the requisite rain water penetration, air leakage, and projectile metrics for a life safety facility. Further, with some of the windows damaged, broken, or losing their seal, replacement of the windows is warranted.

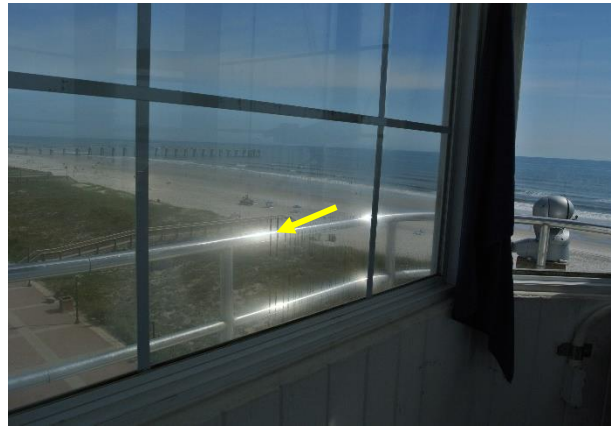
Figure 11. An IGU in the observation deck enclosure has failed. Note the condensation within the unit (yellow arrow).

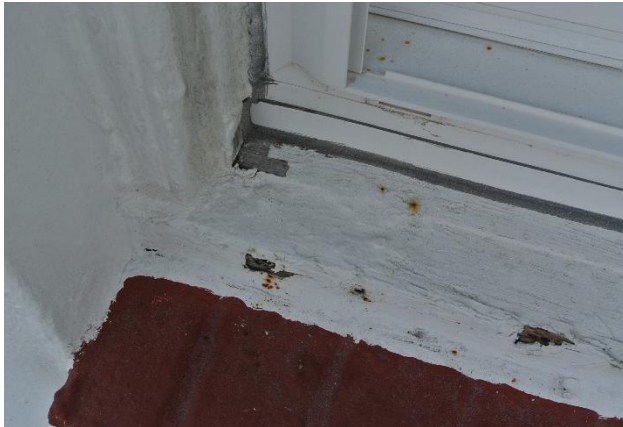
Figure 12. The wood trim around the windows is deteriorated.

The wood trim has experienced a similar fate as the walls. It too was painted and as water permeates or leaks into the trim, drying outward is restricted. As such, the wood begins to rot and deteriorate as observed throughout the building. Similarly, the salinity of the water has corroded fasteners not only within the trim, but of the windows, doors, and hardware.

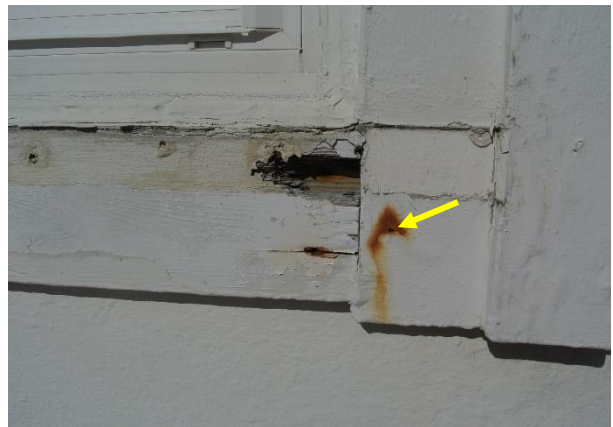
Figure 13. The wood trim around the windows is deteriorated. Corrosion staining from fasteners (yellow arrows) is also apparent.

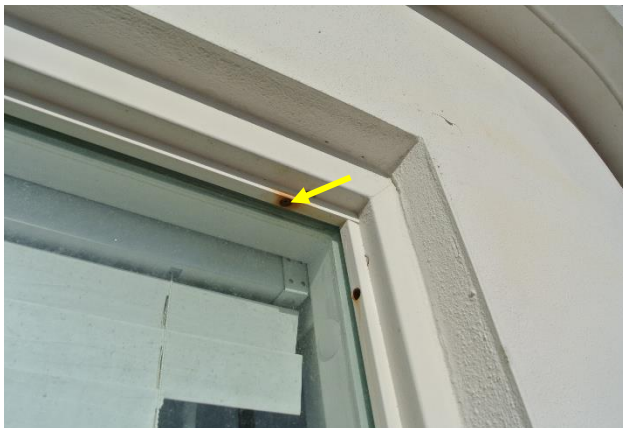
Figure 14. Window fasteners are exhibiting surface corrosion (yellow arrow).

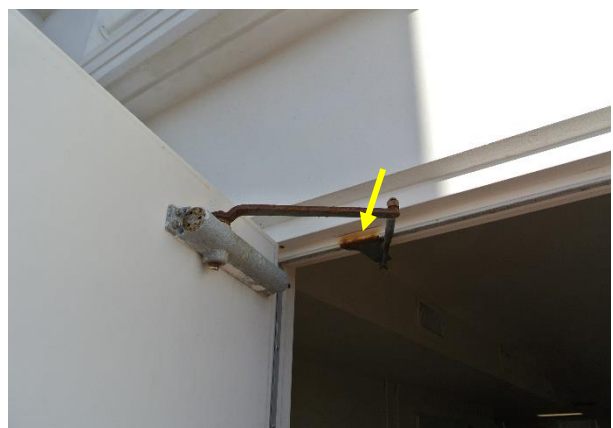
Figure 15. Door hardware throughout the facility is showing varying degrees of corrosion (yellow arrow).

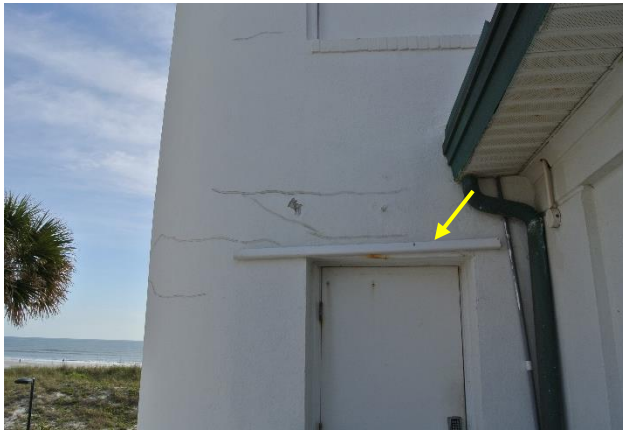
Figure 16. A gutter has been installed above a second-floor door at the watch tower (yellow arrows).

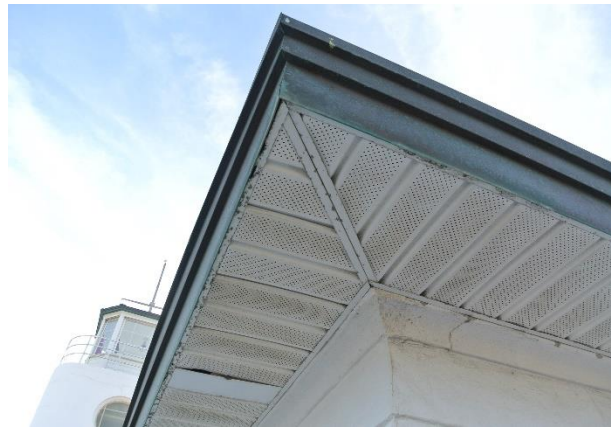
Figure 17. The eave soffit is vented around the perimeter of the two-story structure.

While no reported or evidence of water leakage associated with the roofing was observed, the current configuration of the steep-sloped roofing could have a negative impact on the overall performance. In order for natural ventilation to work on steep-sloped roofs, there must be a clear air space between the eave and ridge with vents at both that provide the requisite air exchange. While the eave soffit maintains open ventilation, the ridge does not appear to provide the needed net free ventilation area, as only one vent is provided on the north. Without proper ventilation, the hygric buoyancy of warm, humid air (not uncommon for the location) can significantly increase the moisture content of wood framing and decking near the ridge which can lead to rot and/or mold.

Further investigation into the ventilation of the steep-slope roof is warranted to ensure that wood framing at the ridge condition is not compromised by increased humidity and moisture levels.

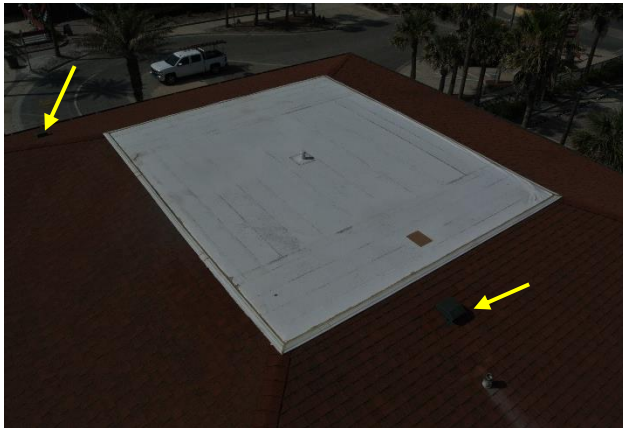
Figure 18. Two box vents (only one is truly near the ridge) exist at the steep-sloped roof (yellow arrows).

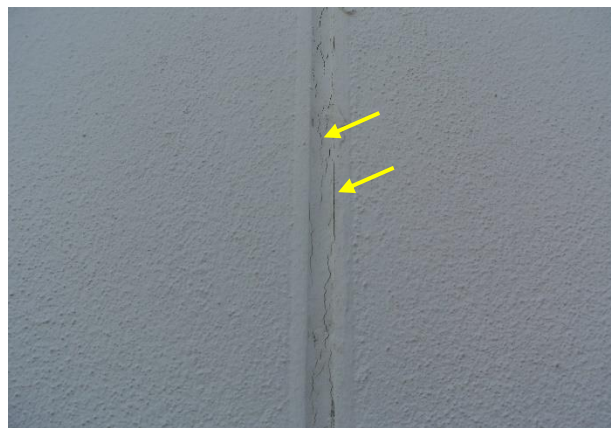
Figure 19. Sealant is experiencing adhesive and cohesive failures (yellow arrows).

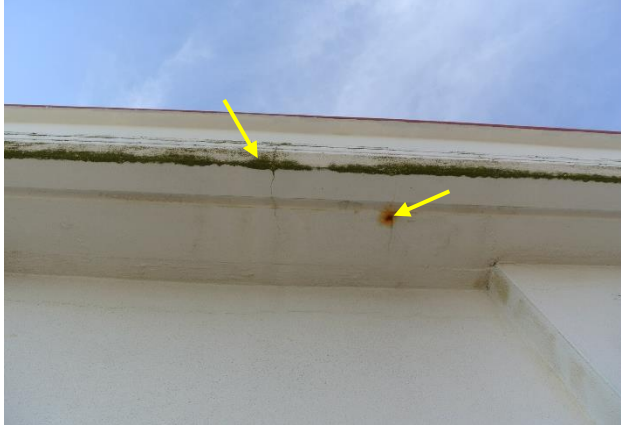
Figure 20. Biological growth, cracking, corrosion staining (yellow arrow) is present along the north facade of the addition.

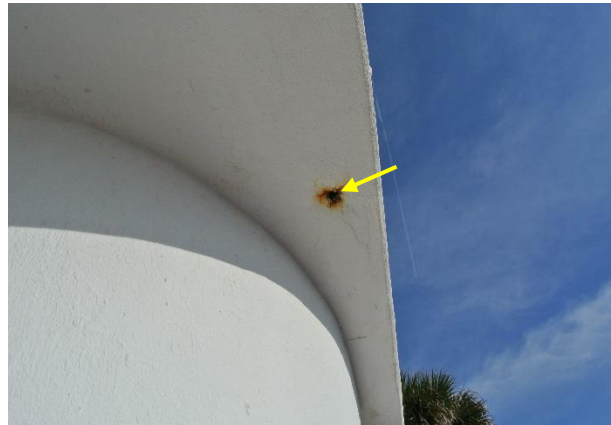
Figure 21. The drain inserts through the concrete overhang are exhibiting corrosion (yellow arrow).

For the concrete overhangs, consider a new waterproofing coating on the skyward face along with the removal of the ferrous drain insert. A new aluminum insert integrated into the new coating is recommended.

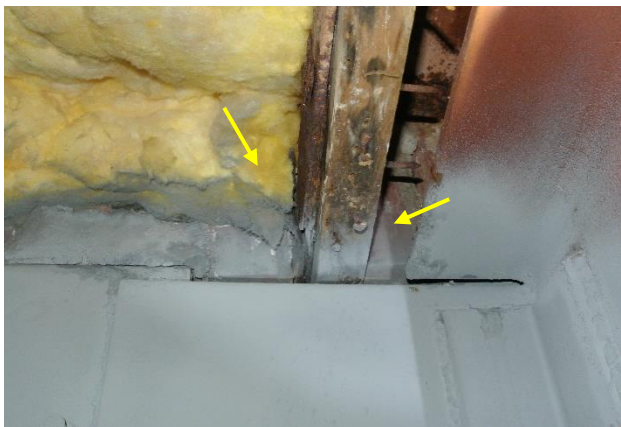
Figure 22. Water staining on and deterioration of the wood joists and floor boards was noted (yellow arrows) .

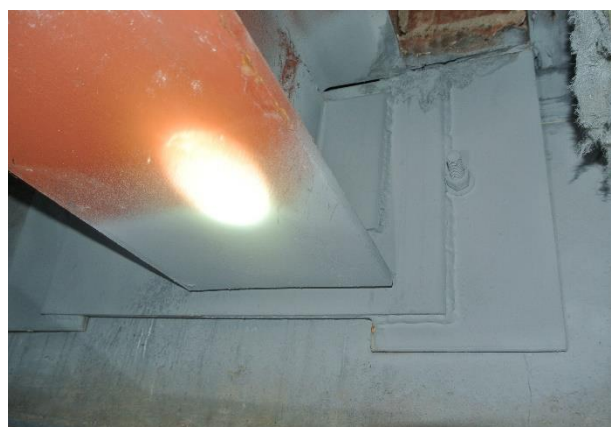
Figure 23. The new beam is welded to a plate that is welded to plates anchored into the wall.

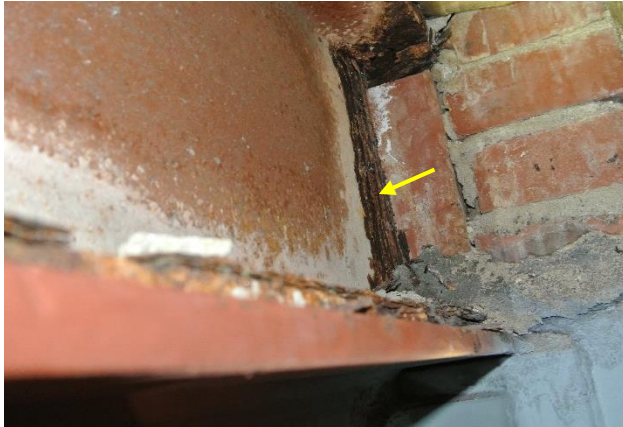
Figure 24 The existing beam is severely corroded (yellow arrow) near the exterior wall.

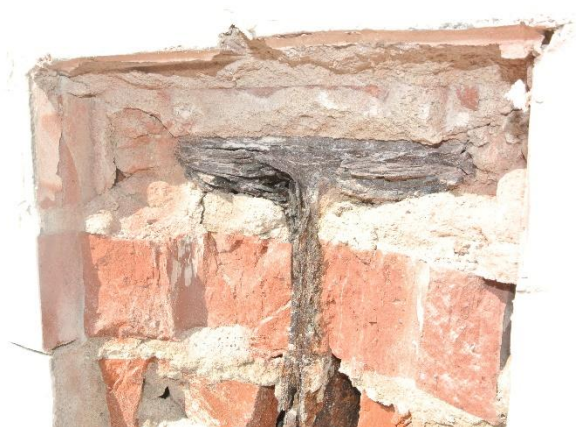
The brick masonry concealing the existing beam pocket was removed. The outboard edge of the existing beam seen in Figure 24, is thoroughly corroded (Figure 25). Most of the flange and web have been completely consumed.

Figure 25. The end of the existing beam is thoroughly corroded where it is embedded into the brick masonry.

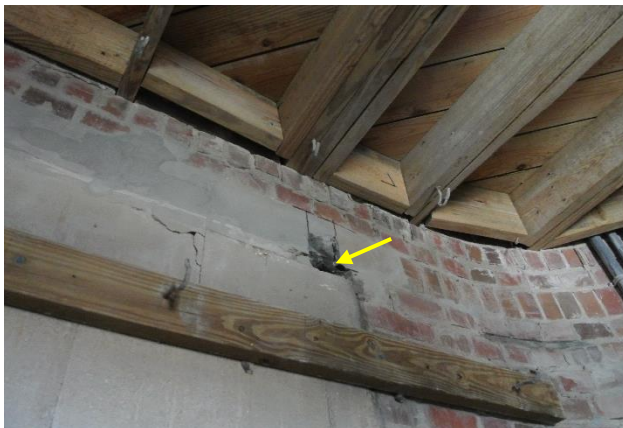
A portion of a previous concrete repair was chipped out to expose the underlying construction (Figure 26). Concealed is a steel lintel that exhibits similar corrosion noted at the exterior beam pocket (Figure 27).

Figure 26 A small portion of the previous concrete repair was removed to expose the lintel.

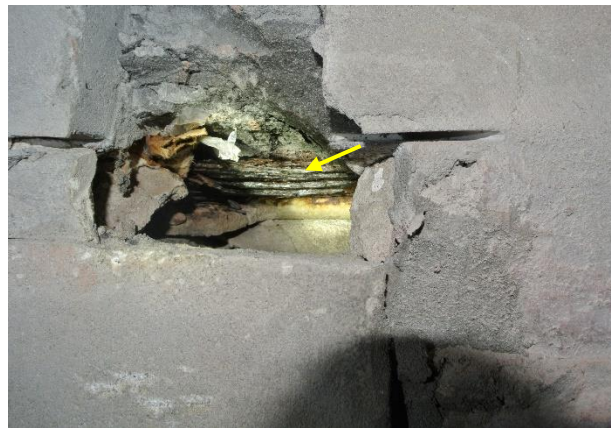
Figure 27. The steel lintel is heavily corroded similar to the steel beam in Figure 25.
