BAYMEADOWS SOUTHEASTERN PORTION OF THE MASTER LAKE SYSTEM CRITICAL DRAINAGE COMPONENTS AND OPERATION AND MAINTENANCE GUIDELINES

BAYMEADOWS SITES
 FOR
 D.R. HORTON, INC. - JACKSONVILLE

SOUTHEAST CORNER DRAINAGE MAINTENANCE PLAN

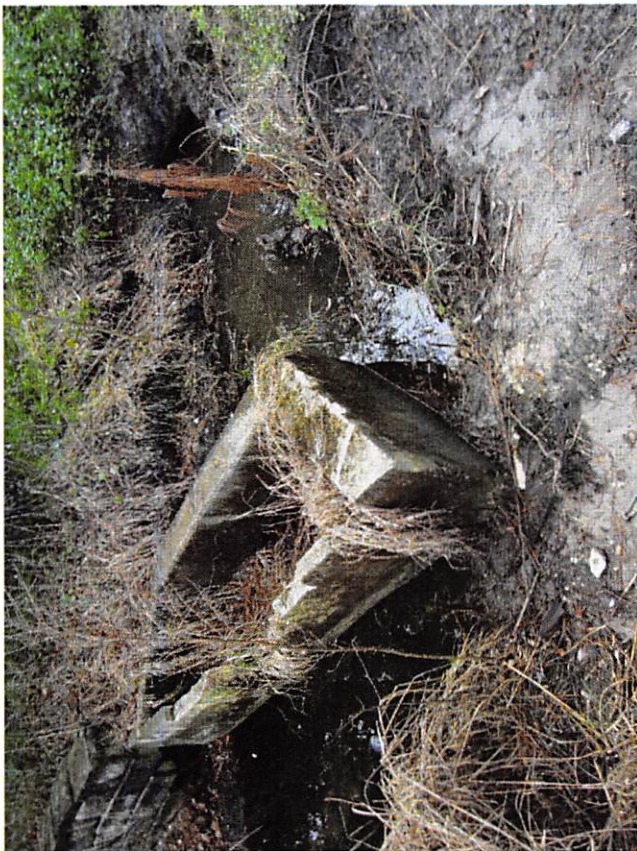
- MES #1, Keep the Baypointe inflow MES clear of vegetative growth with monthly inspections
- CS #1, Headwall / Weir (Photos 1 and 2) is not functioning. Structure needs to be retrofitted to original design including reconnecting structure to discharge pipe. This connection is offsite on private property and should be rebuilt. Pond 2 to the north appears to have reasonable freeboard; however, drainage into and around pond 2 from the north and east has not been evaluated as part of this effort.
- HW #1, Culvert is silted in. Recommend removing silt from culvert and ditch to allow for positive discharge.
- Ditch is silted in. The excess debris and vegetation should be removed.
- HW #2 (Photo 3) needs to be inspected for silt and debris. Any blockage needs to be removed.
- CS #1, the ditch and HW #2 needs monthly inspections and debris removal and corrective work performed, as needed.

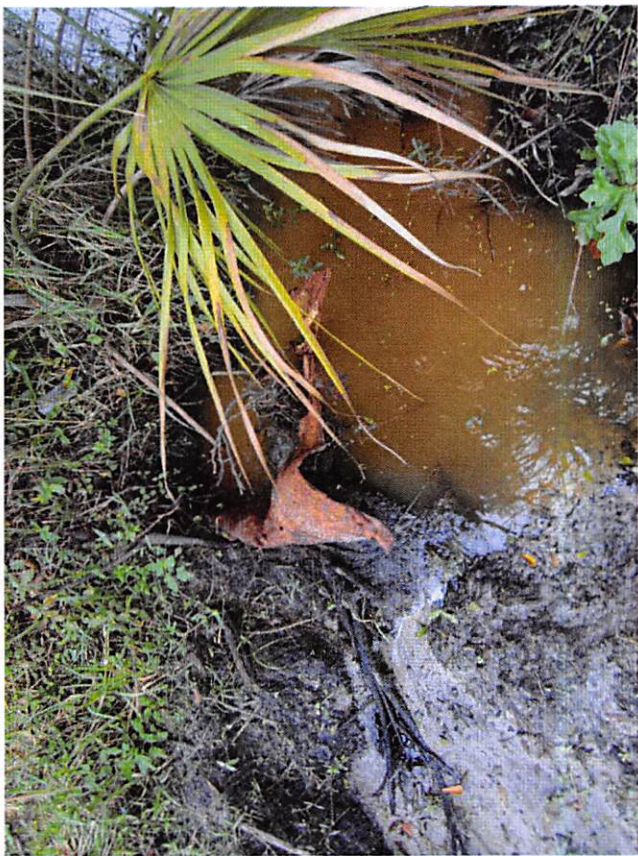
4

- CMP #1, has no end treatment and has been crushed (Photo 4) . This culvert is offsite on private property and needs to be replaced along with a proper end treatment constructed.

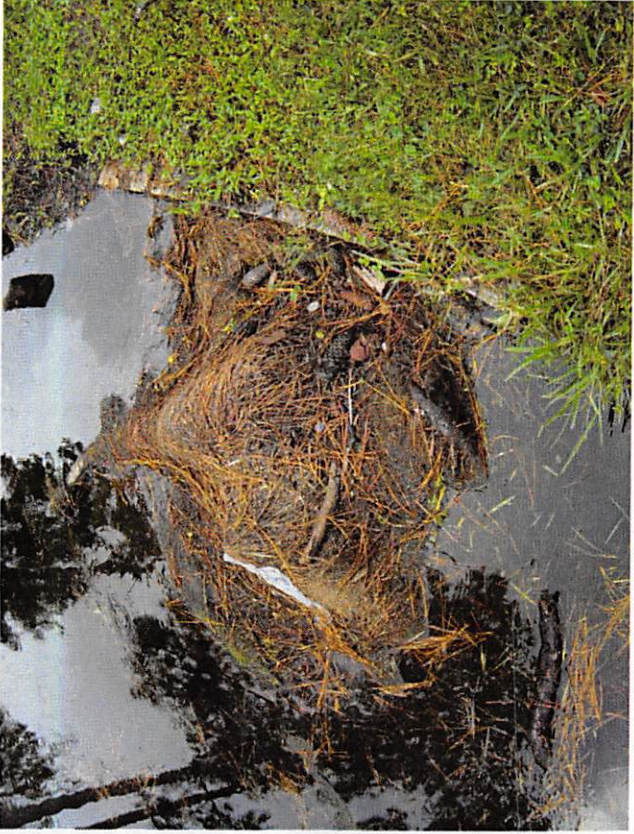
6

- FL #9, appears clear with no issues
- CS #9, The CS was submerged due to the grate being clogged (Photos 6-9). All vegetation and silt needs to be removed. An exterior baffle / skimmer would help limit debris from clogging the grate. Weekly debris removal is required. A weir could be constructed in the side of the CS below the grate to increase Pond 9 storage volume and reduce the pond stage if flooding is a concern.
- HW #9s, The ditch between the Headwalls is choked with fallen trees and debris (Photos 10 and 11). Entire ditch should be cleaned to ensure efficient flow.

- CS #9 should be inspected weekly and cleaned. HW's and ditch needs semiannual inspections and debris removal and corrective work performed, as needed.

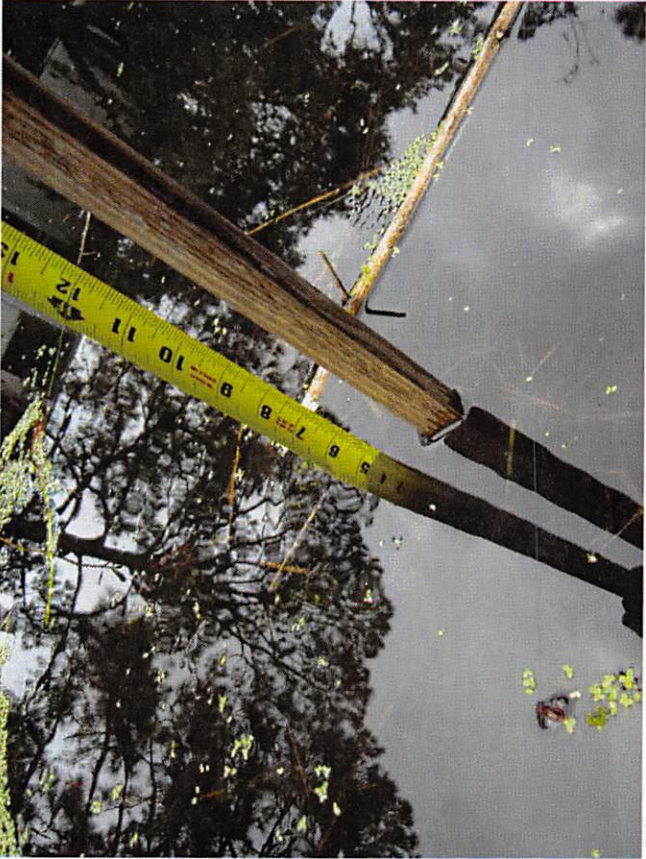
- MES #2, Keep the Baypointe inflow MES clear of vegetative growth with monthly inspections.
- CS #2, The current structure has a grate elevation at 25.0 and had 5 – inches water above the grate during our inspection (Photo 5). The CS will be modified to include a 3' wide weir at elevation 24 or possibly 23.5 to increase storage in pond 1. The pre-existing pipe crossing the golf course was at invert elevation 24.8 and silted in to elevation 25. The lowered NWL has been discussed with Elmedin Strikovic with GoldOller.

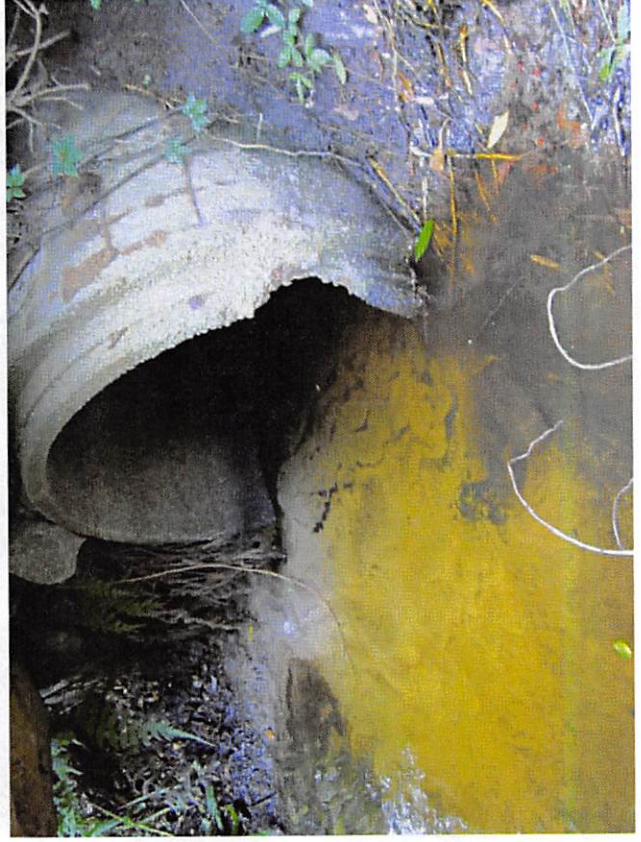
12

- RCP #4 (Photo 12), There is considerable flow discharging into HW #9 but little apparent flow discharging from RCP #4 to Pond 4. Culvert between HW #9 and RCP #4 should be inspected to determine how the water is flowing.
- Culvert between HW #9 and RCP #4 needs semiannual inspections and debris removal and corrective work performed, as needed.
