BAYMEADOWS SOUTHEASTERN PORTION OF THE MASTER LAKE SYSTEM CRITICAL DRAINAGE COMPONENTS AND OPERATION AND MAINTENANCE GUIDELINES

BAYMEADOWS SITES
 FOR
 D.R. HORTON, INC. - JACKSONVILLE

SOUTHEAST CORNER DRAINAGE MAINTENANCE PLAN

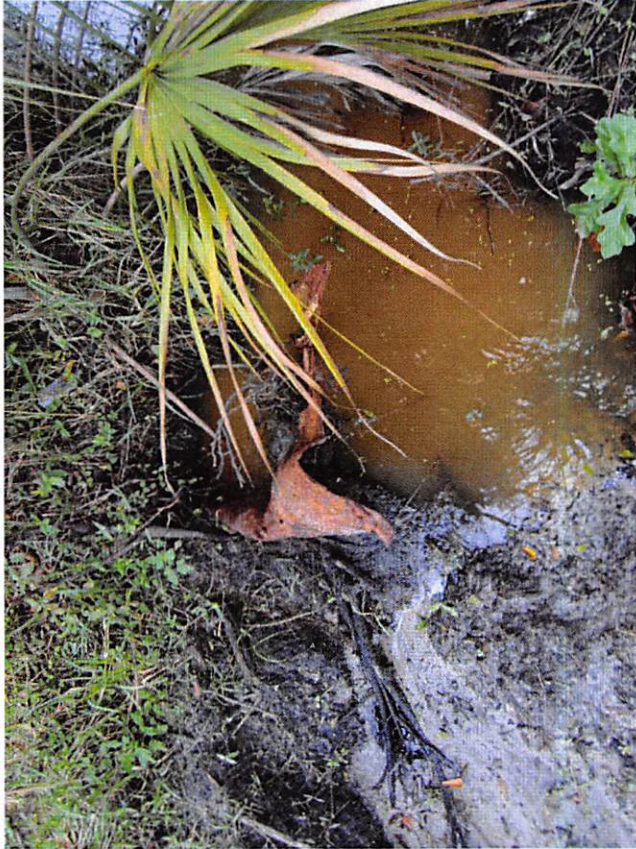
4

- CMP #1, has no end treatment and has been crushed (Photo 4) . This culvert is offsite on private property and needs to be replaced along with a proper end treatment constructed.

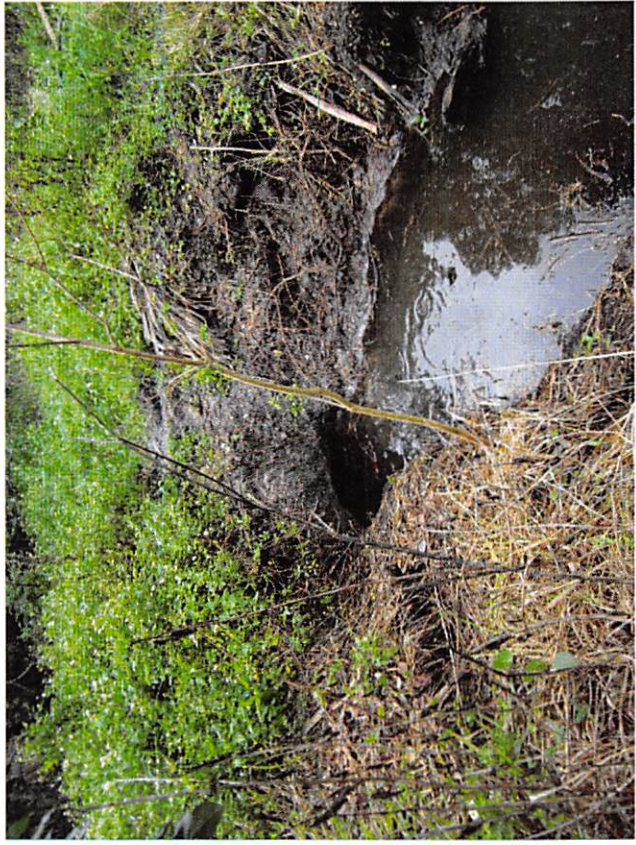
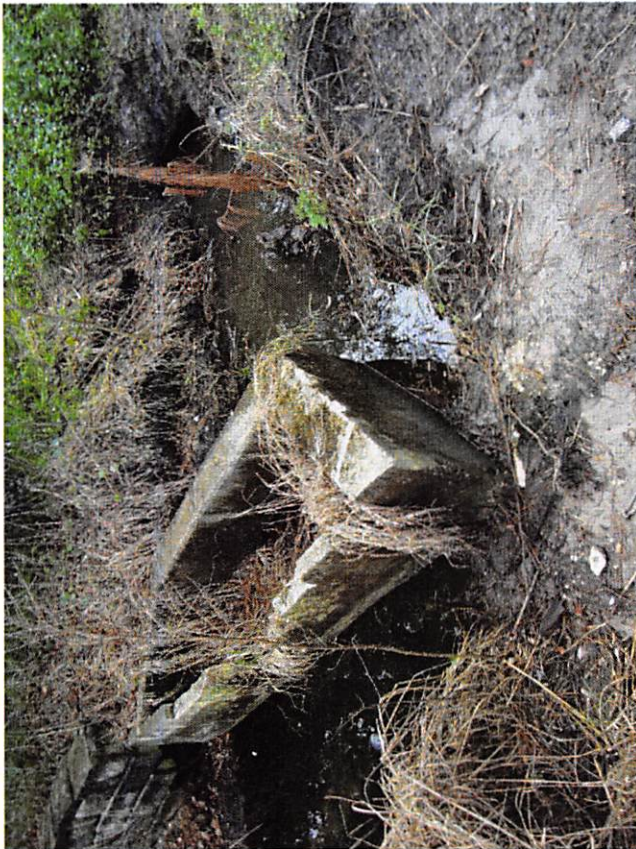
- MES #1, Keep the Baypointe inflow MES clear of vegetative growth with monthly inspections
- CS #1, Headwall / Weir (Photos 1 and 2) is not functioning. Structure needs to be retrofitted to original design including reconnecting structure to discharge pipe. This connection is offsite on private property and should be rebuilt. Pond 2 to the north appears to have reasonable freeboard; however, drainage into and around pond 2 from the north and east has not been evaluated as part of this effort.
- HW #1, Culvert is silted in. Recommend removing silt from culvert and ditch to allow for positive discharge.
- Ditch is silted in. The excess debris and vegetation should be removed.
- HW #2 (Photo 3) needs to be inspected for silt and debris. Any blockage needs to be removed.
- CS #1, the ditch and HW #2 needs monthly inspections and debris removal and corrective work performed, as needed.

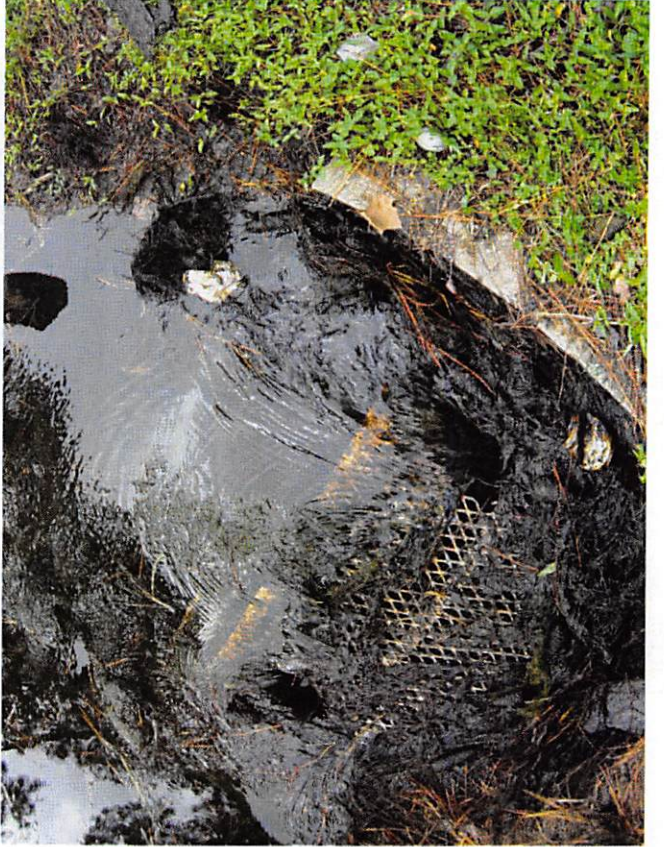
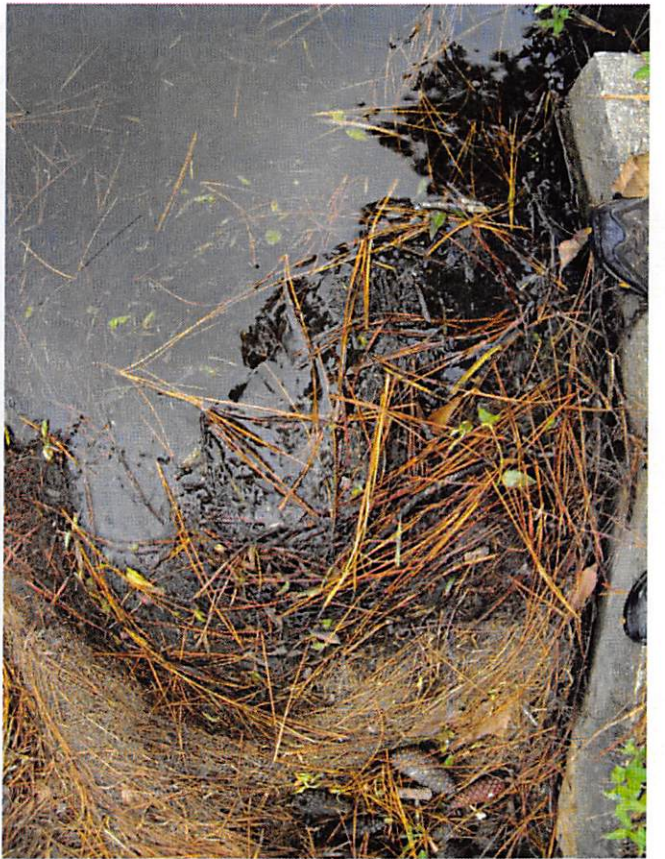
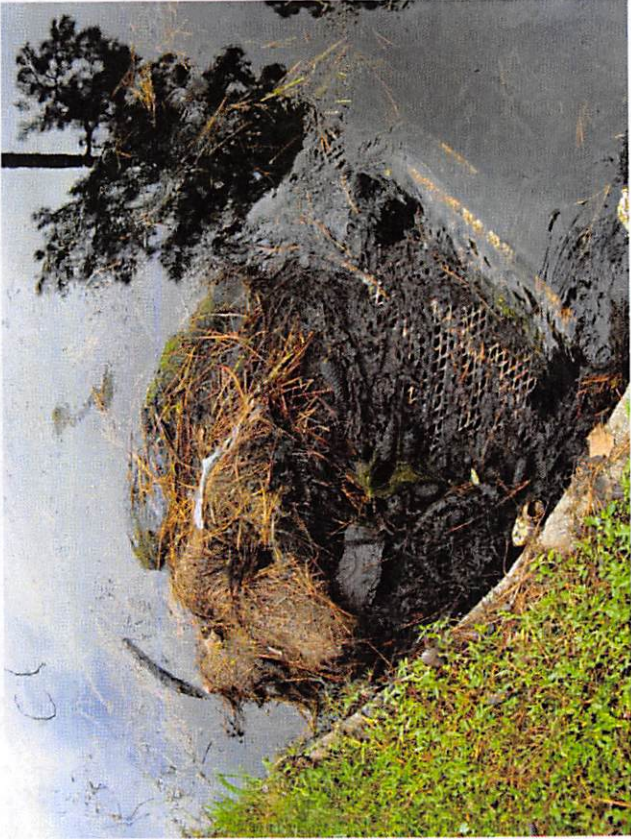
- FL #9, appears clear with no issues
- CS #9, The CS was submerged due to the grate being clogged (Photos 6-9). All vegetation and silt needs to be removed. An exterior baffle / skimmer would help limit debris from clogging the grate. Weekly debris removal is required. A weir could be constructed in the side of the CS below the grate to increase Pond 9 storage volume and reduce the pond stage if flooding is a concern.
- HW #9s, The ditch between the Headwalls is choked with fallen trees and debris (Photos 10 and 11). Entire ditch should be cleaned to ensure efficient flow.

- CS #9 should be inspected weekly and cleaned. HW's and ditch needs semiannual inspections and debris removal and corrective work performed, as needed.

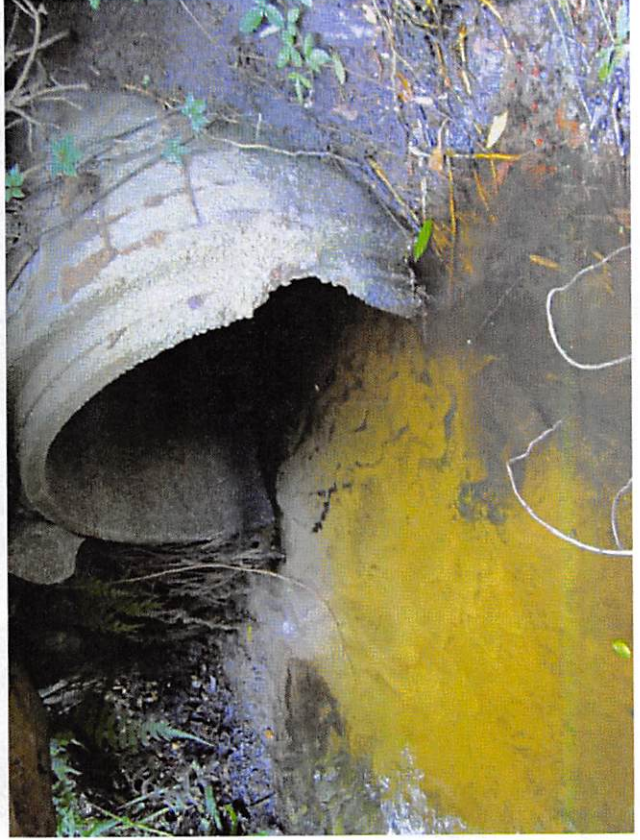
12

- RCP #4 (Photo 12), There is considerable flow discharging into HW #9 but little apparent flow discharging from RCP #4 to Pond 4. Culvert between HW #9 and RCP #4 should be inspected to determine how the water is flowing.
- Culvert between HW #9 and RCP #4 needs semiannual inspections and debris removal and corrective work performed, as needed.
