Historic Stanton Repairs

521 W Ashley

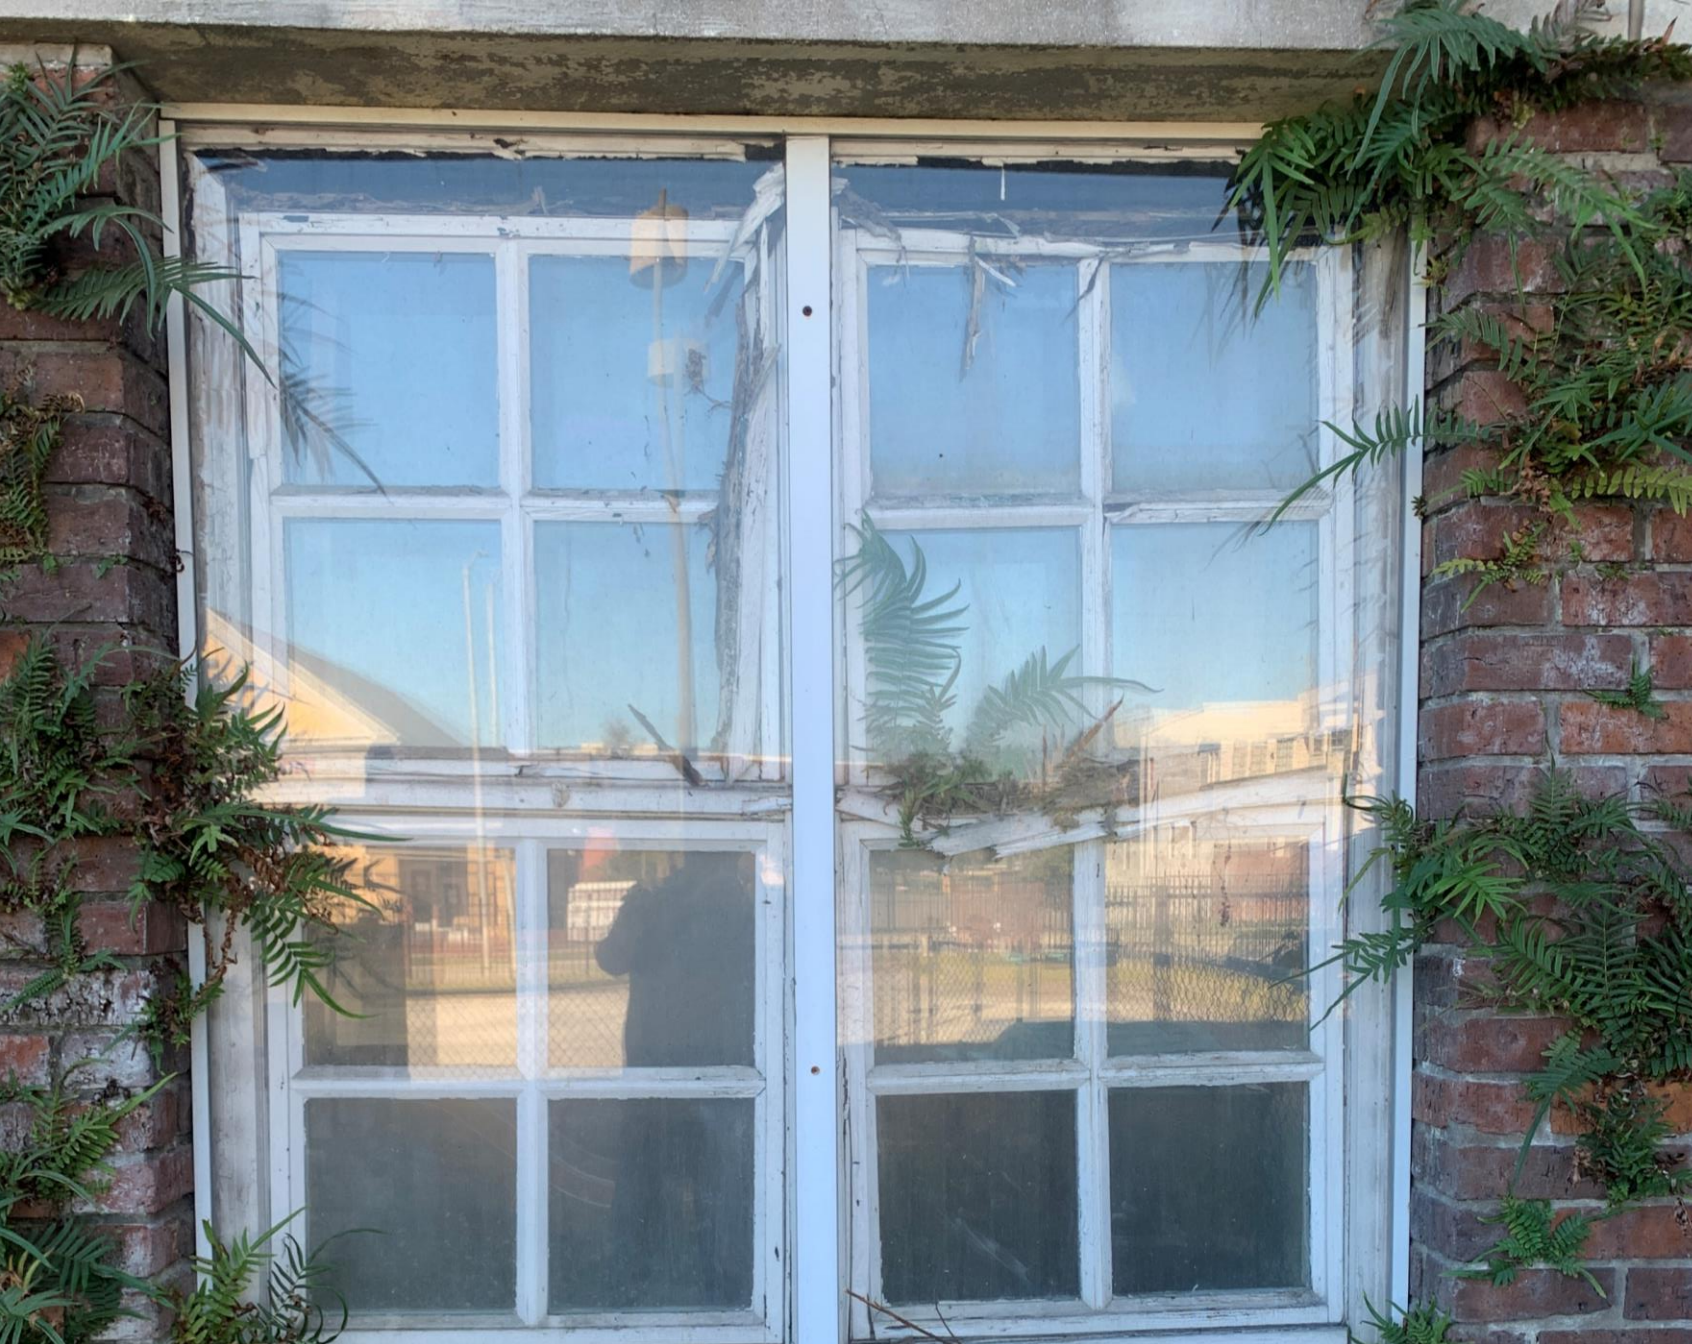
1st Floor windows
mostly original and
covered in
plexiglass

- Care will be taken to 2x4
block around windows
and board up so as not to
compromise casings and
frames

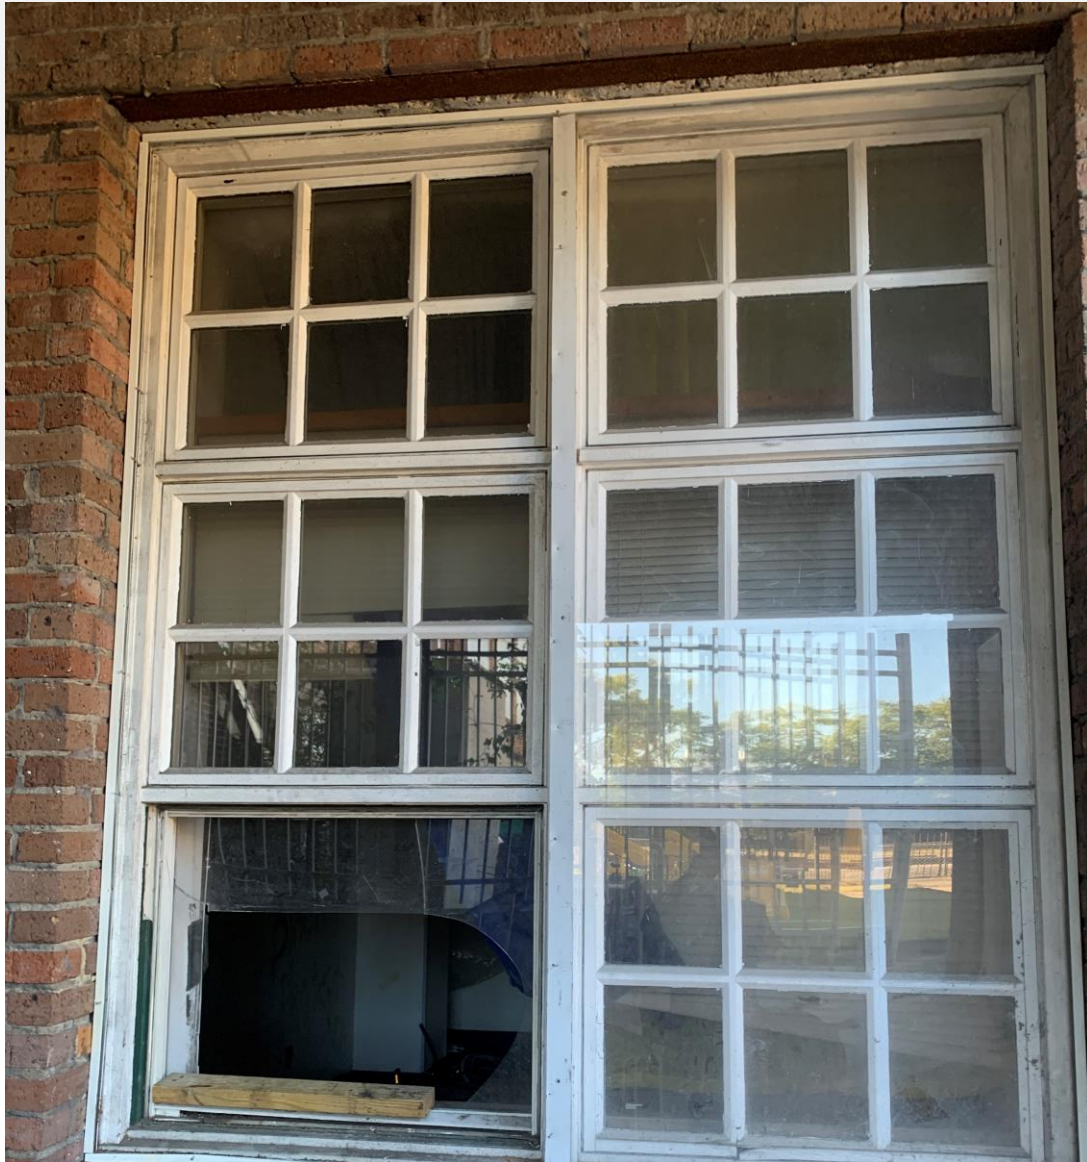
Entry way for vagrants

- Boarding up the first floor and accessible second floor windows ASAP to stop intrusion into building. Winter is here and fires will come.

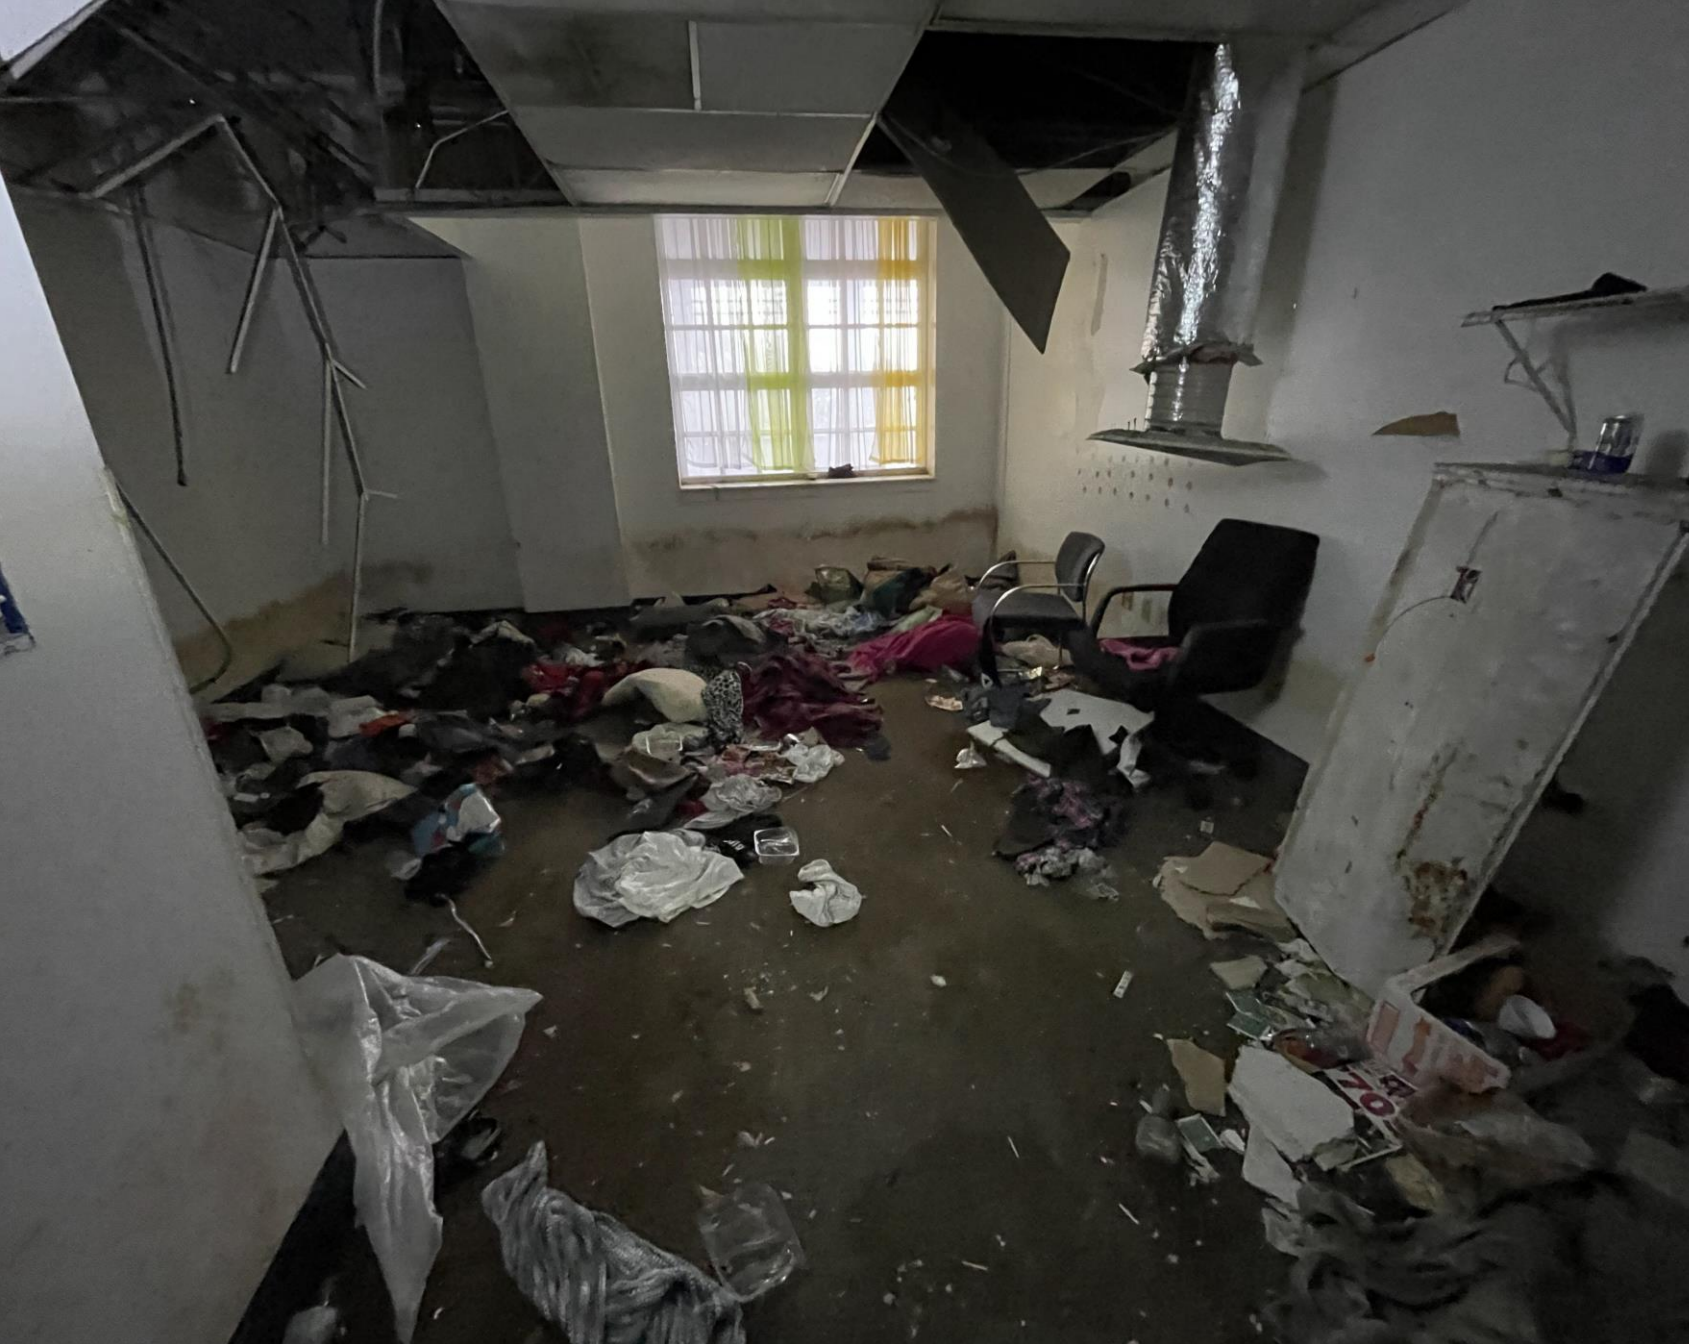
First Floor Demo

- The first floor is the only floor not previously demo'ed. It housed a tenant as recently as 3 years ago. All acoustic ceiling, lighting, wires, conduit, duct work, trash, etc. will be removed

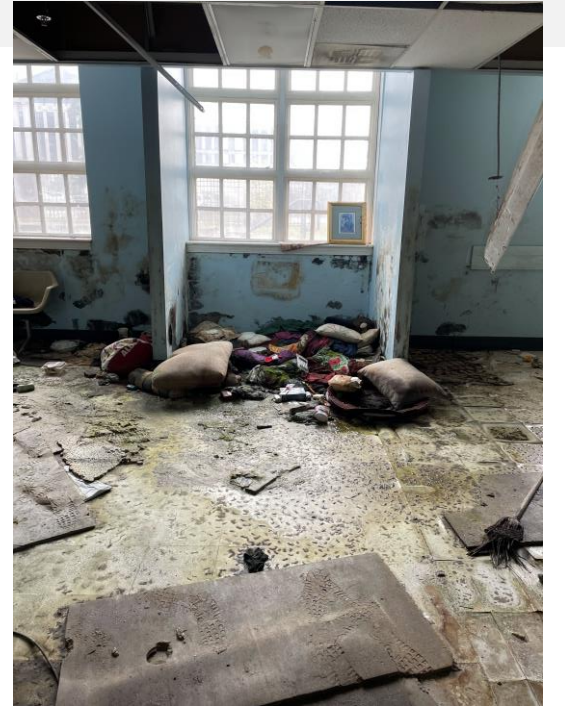
Roof Repair

- The trusses called for are a 4-6 month lead time. Contractors may choose to frame in place for repair.

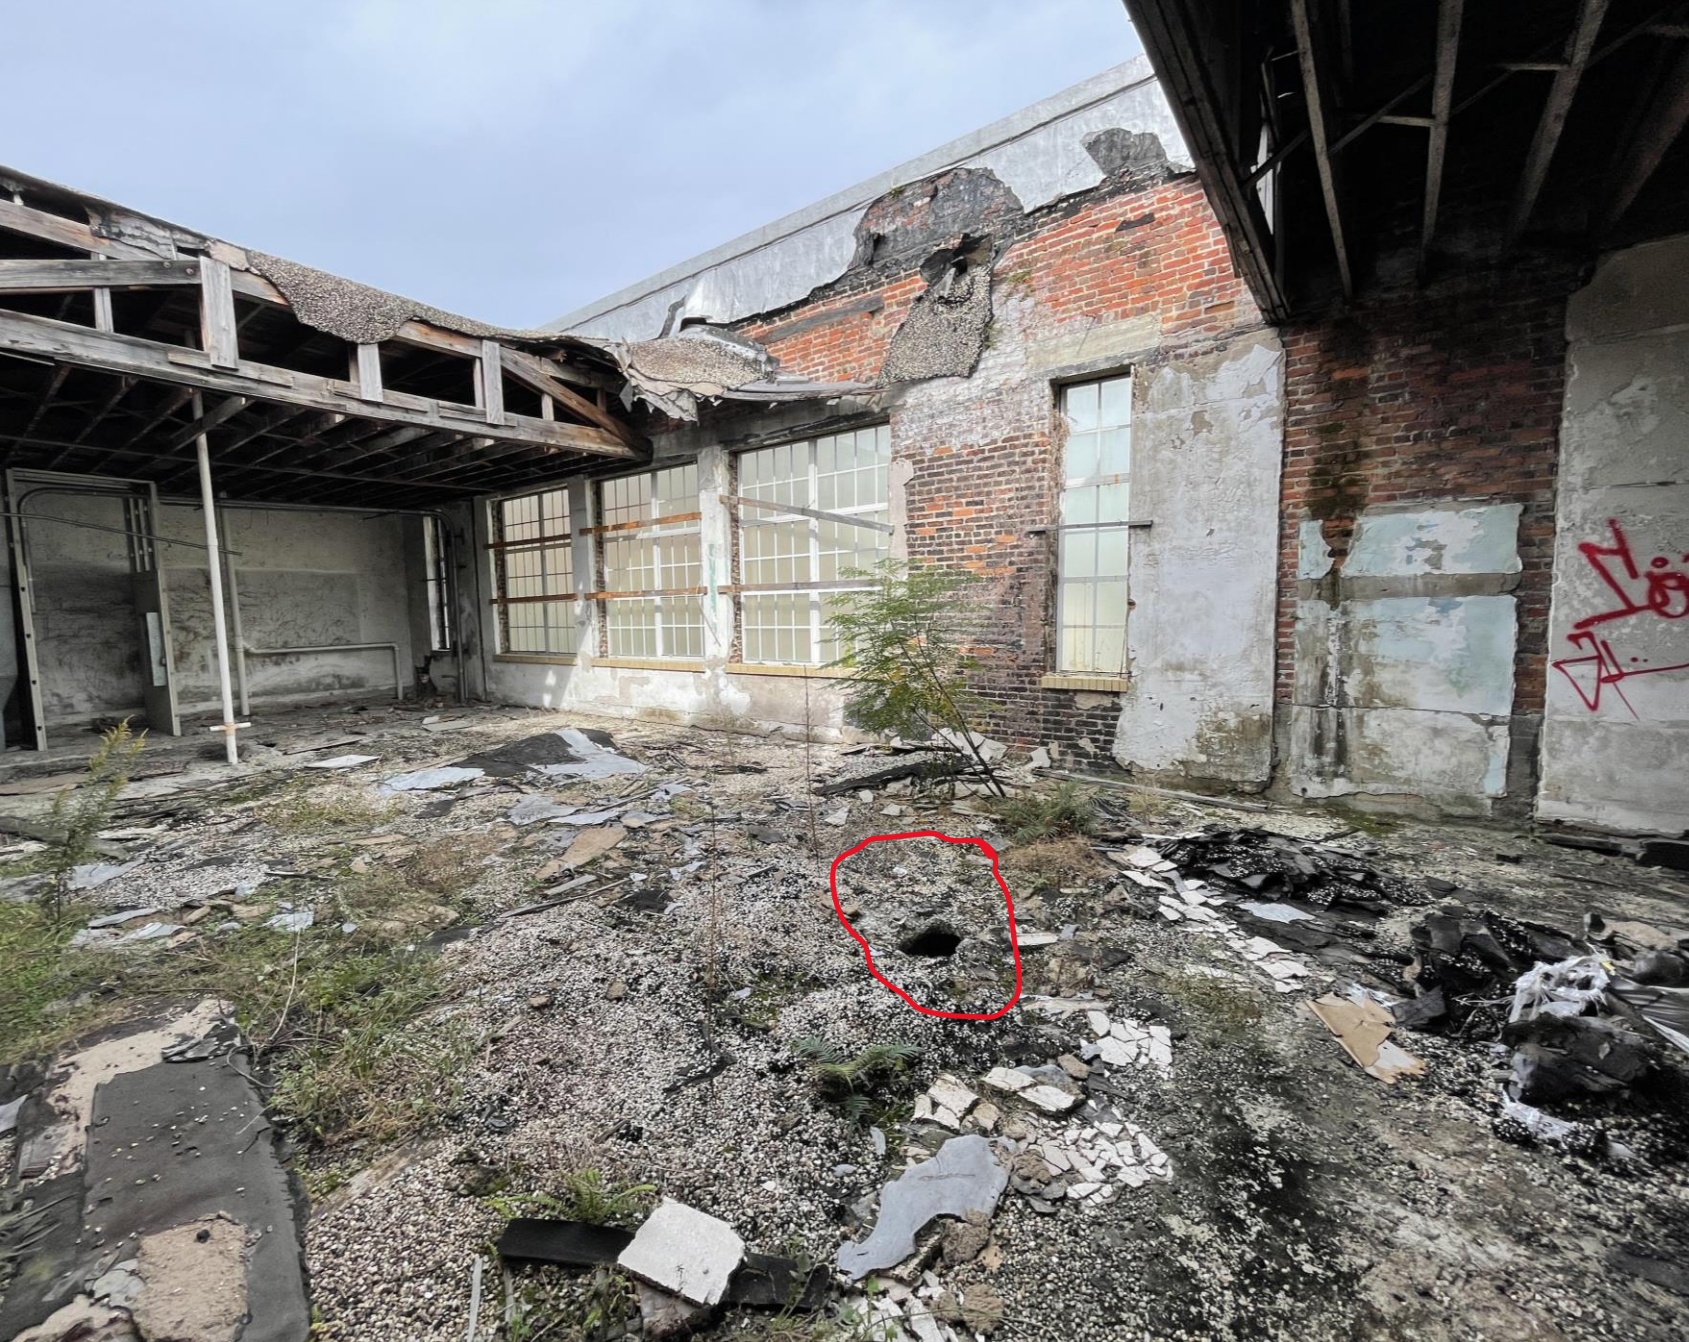
Floor under roof opening

- There is concern about the stability of the floor below the open roof. See hole already created by wash out of rain.
