# HISTORIC PRESERVATION PROPERTY TAX EXEMPTION APPLICATION PART I--PRECONSTRUCTION APPLICATION

Property identification and location:
Property Identification Number (from tax records): <u>074645-0000, 074637-0000, 074638</u> Attach legal description of property
Address of property: 525 West Beaver Street
City <u>JACKSONVILLE</u> , County: <u>DUVAL</u> Zip Code: <u>32202</u>
☐ Individually National Register Listed ☐ Locally designated historic property or landmark*
☐ In a National Register District ☐ In a locally designated district

The Hillman-Pratt Funeral Home has vernacular architectural elements of the Gothic Revival and Richardsonian Romanesque styles. Vernacular Gothic Revival elements include the embattled parapet walls and Gothic-arched chapel windows, which vernacular examples of the Romanesque style include the use of textured brick, round-arched niches, and round-arched vents in the parapet (photos 3,7, and 11). These vernacular buildings often used brick masonry and stucco finishes on the exterior, which are found on this property.

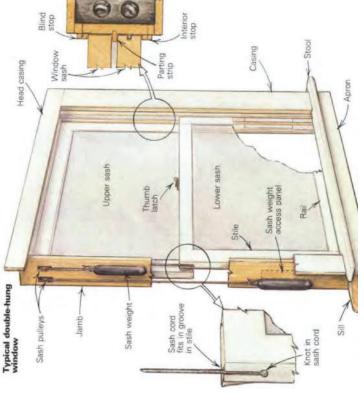
The two surviving sashes (red arrows) were installed in the nonhistoric demising wall outside of the Period of Significance according to Irvlyn Kennebrew who lived above the funeral home with her parents in the mid-century.

The contractor intends to keep the assemblage of the two stained glass window sashes simple, as shown in sketch above, and in section below.

- 3. Windows: Details of the two stained-glass window sashes to be repaired (at the interior vestibule of the chapel) must be submitted for review and approval, including dimensioned drawings of the new window components and materials.

3. Windows: Details of the two stained-glass window sashes to be repaired (at the interior vestibule of the chapel) must be submitted for review and approval, including dimensioned drawings of the new window components and materials.

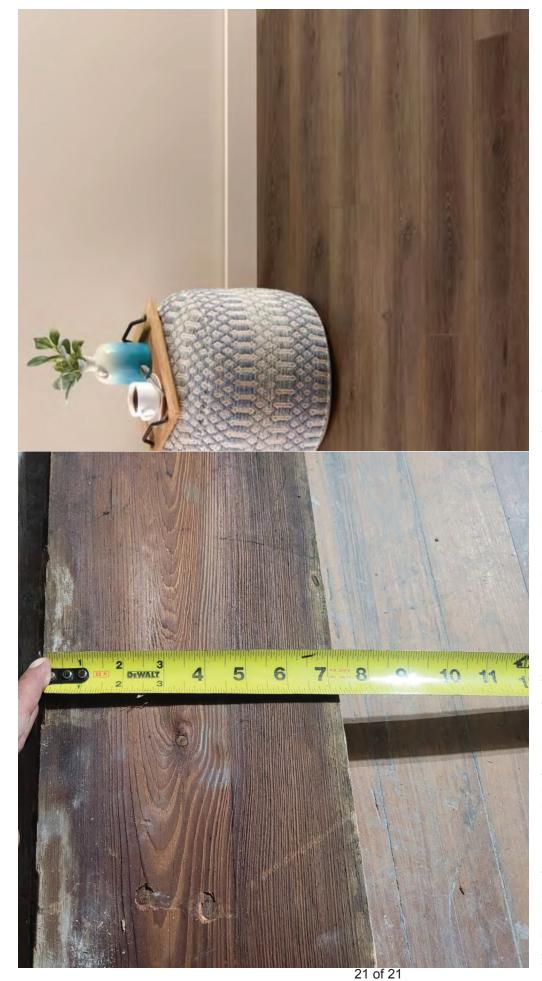
1.8a: Product Data for proposed laminate vinyl plank flooring for casket factory.

1.8b: The width of the wood planks found on the first floor garage are likely what was on the casket factory floor. These were approximately 7" wide and were in a typical staggered pattern like most wood floors.

When the nonhistoric laminate was removed from the casket factory we found that the wood plank flooring that had been present had been removed previously and new plywood applied in its place as a subfloor for the new laminate floor. As this is a missing feature we propose a laminate vinyl plank flooring to be used in its place, see Figure 1.8a. From discussions with Mrs. Kennebrew, she recalls that the plank flooring found in the garage was also found in the casket factory. The planks found in the garage are approximately 7" wide and staggered in placement like a typical floor. The laminate vinyl plank (LVP) sample we have found is a close color match to the existing flooring of the garage, while its width is approximately 9" or a 22% larger width. Other LVP was much thinner (approximately 2" - 3" in width or 57% smaller width). The length of our proposed product is 6'. This LVP product was choosen as to buy new wood 7" planks would be cost prohibitive. Since there were no extant planks this change in material and size should not be noticable given the space is subdivided into units.

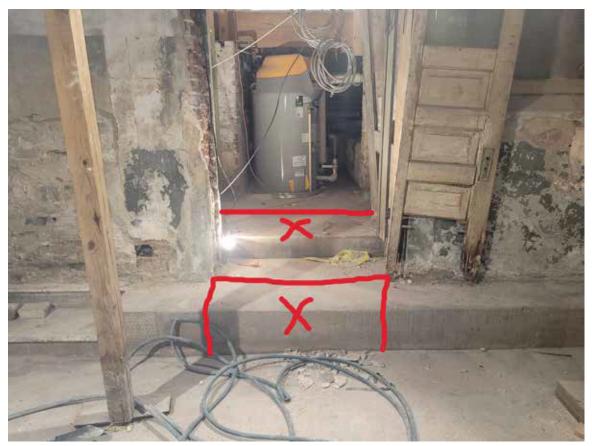
Figure A-1: These steps will be lowered to meet code. Build back will be concrete. The main tile floor will be unaltered.

- 1. Basement: In the original Federal Part 2 Application (see sheet A1.4) the plaster ceiling was to be repaired and fire-rated, plumbing was added to include a mop sink. In our revised plan the ceiling will still be repaired and the tile floor will remain, but the stair to the basement is being widened to meet code to make the basement accessible which will require removal of part of the southern cheek/retaining wall of the basement stairs to add approximately 12" in width to the stairs (see Figures A-1 & A-2). Where the header is at the bottom of the stairs would also need to be raised approximately 9" (see Figure A-3). See Structural drawings in Appendix A.
- 2. An awning will be added to the new entrance on the west elevation. This awning will be a fabric awning sized to the opening, see Appendix B.
