**HISTORIC PRESERVATION PROPERTY TAX EXEMPTION APPLICATION  
PART I--PRECONSTRUCTION APPLICATION**

Address of property: 2739 Post Street

Name of historic district: Riverside National Register District

Existing Conditions at:  
**2739 Post Street**  
Jacksonville, Florida

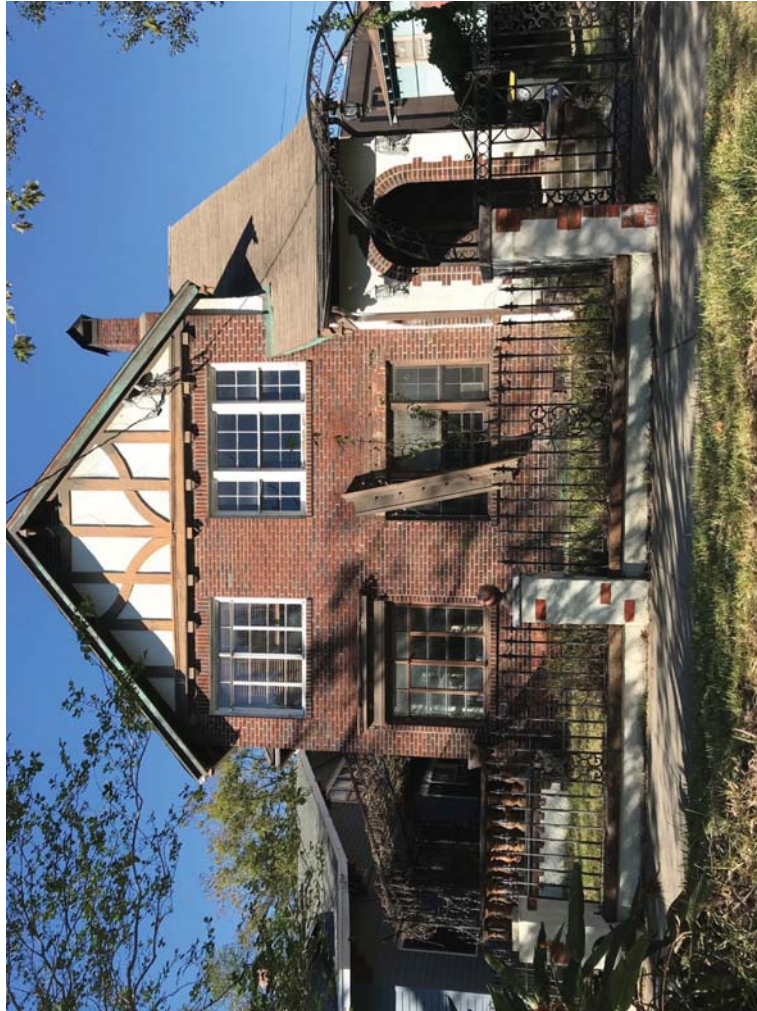
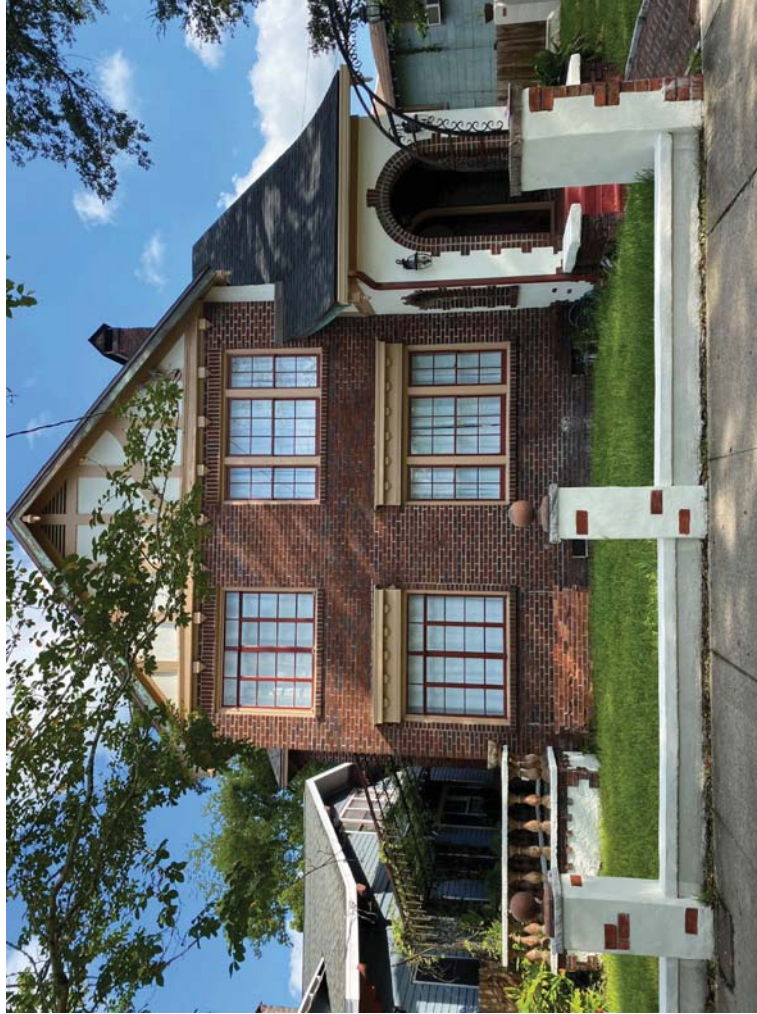
Photo 1 Before

The South side of the building faces Post Street, and is the main character contributing elevation. (Photos 1 & 2) The yard is defined with a low masonry wall with cast iron fencing between masonry piers. Some of these piers are topped with decorative spherical finials. A gate and an arched iron trellis lead from the public sidewalk, to a private walkway, to the front door. The masonry wall is in good condition. The iron fencing and trellis are also in good condition but are missing some finials and other decorative pieces. From the historic photo shown in attached master site file (Attachment 4), you can see that this fence is not original.

Describe existing feature and its condition:  
There are exterior sconces and flood lights at the exterior doors. (Photos 1, 3, & 18) There is a pendant installed on the trellis over the porch on the West elevation. (Photo 9 & 24) A flood light on the North elevation lights the back parking area. (Photo 5) Another light is currently installed under the eye brow over the back door.

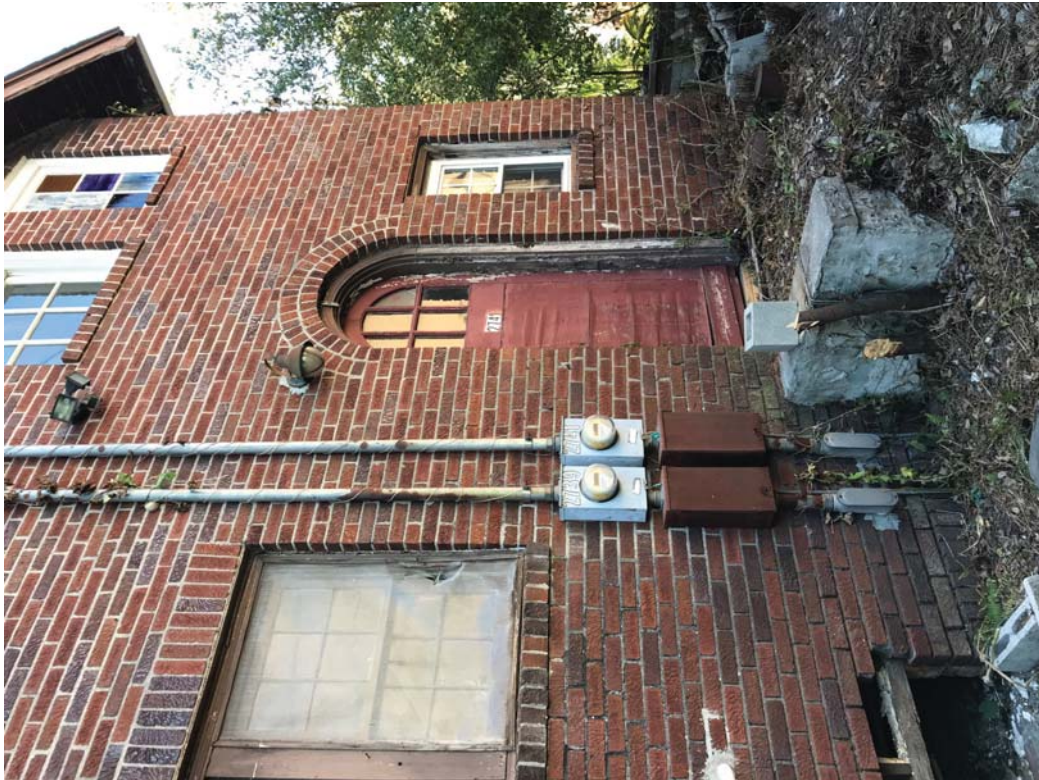
Photo 3 Before

The East entrance has existing concrete steps that have deteriorated and are beyond repair. To the left of the East door, there is some concrete block and brick. The previous intent of these materials is unclear. (Photos 3, 17, 27 & 28)  
Photograph Number: 3, 6, 7, 9, 17, 20-28 Drawing Number: A1, A5, A6 & A10

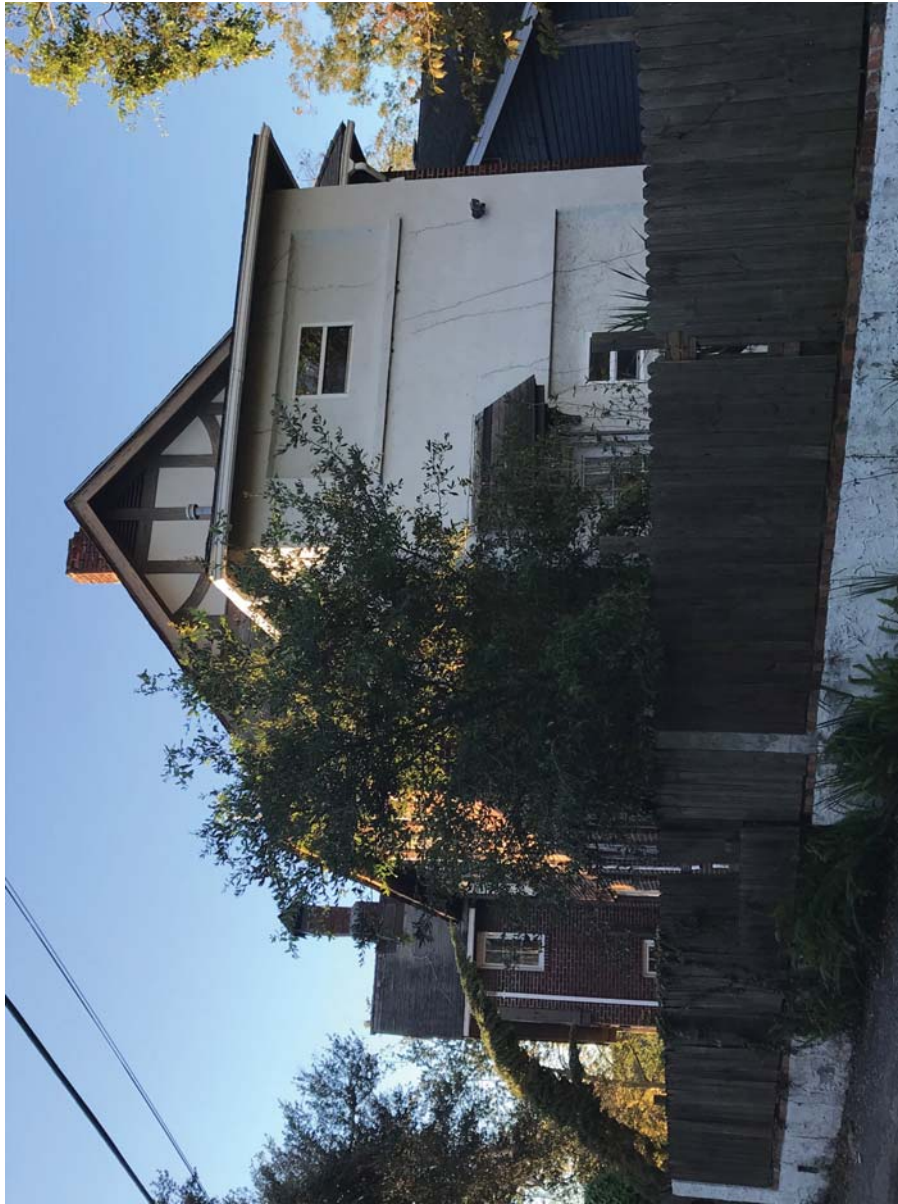
Photo 5 Before

Describe existing feature and its condition:  
 Existing asphalt shingle roof is estimated to be 10-20 years old. Some of the existing fascia and flashing is copper. There are 4 existing skylights serving the 3rd floor, many of which are damaged or are missing. There are two existing chimneys. One is on the South elevation and serves the fireplaces on the first and second floors. The existing chimney cap on this chimney is rusted and damaged. The second chimney is only visible from the alley to the northeast, and is believed to have served a furnace or boiler that was removed by a previous owner.  
 Photograph Number: 1 & 5 Drawing Number: A3-A7

Due to budgetary restraints, the damaged copper flashing and fascia shall be replaced with black anodized aluminum.

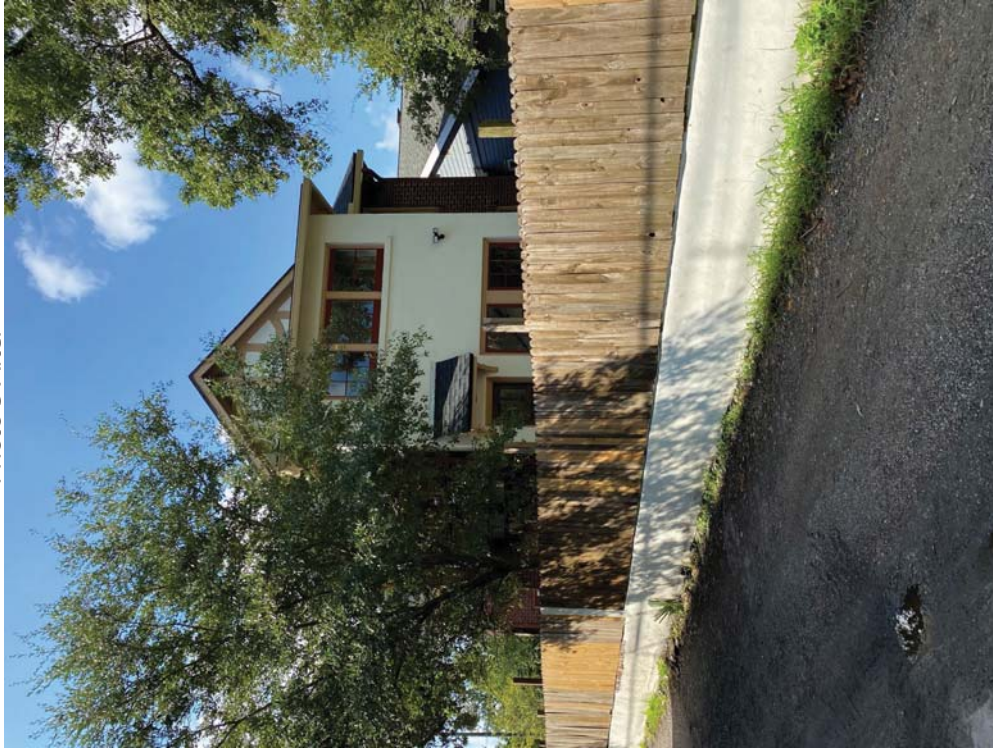
Photo 5 After

The East property line is defined by a low masonry wall, similar to the South elevation, with intermittent masonry piers. (Photo 5) Some of the piers are topped with decorative urns. Between the piers and on top of the masonry walls are wood fence panels with a dog-eared detail at the top.

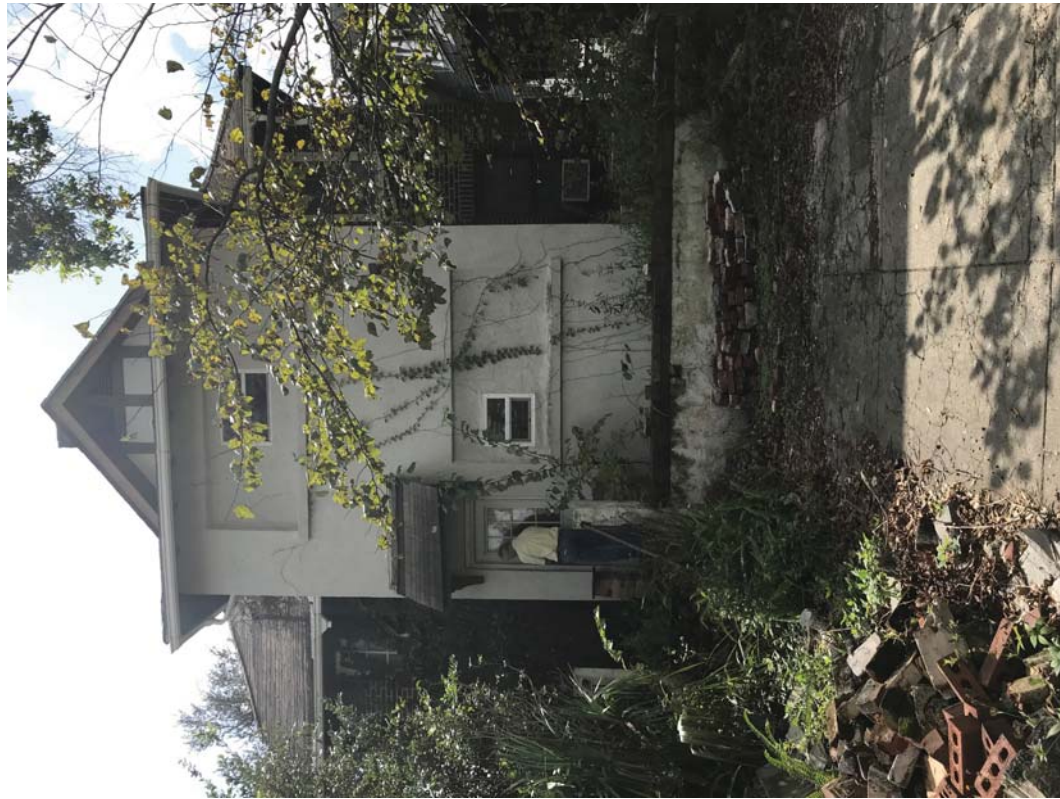
Photo 6 Before

The North and East sides of the building face a service alley common to a restaurant, gas station, and commercial office building. From the 1950's Sandborn map (Attachment 3) we can see that there was a concrete pad behind the building. What remains of that pad is cracked and broken. (Photo 6)

The existing concrete pad in the rear of the building is cracked and broken beyond repair. The old concrete pad shall be removed and a new concrete pad poured.

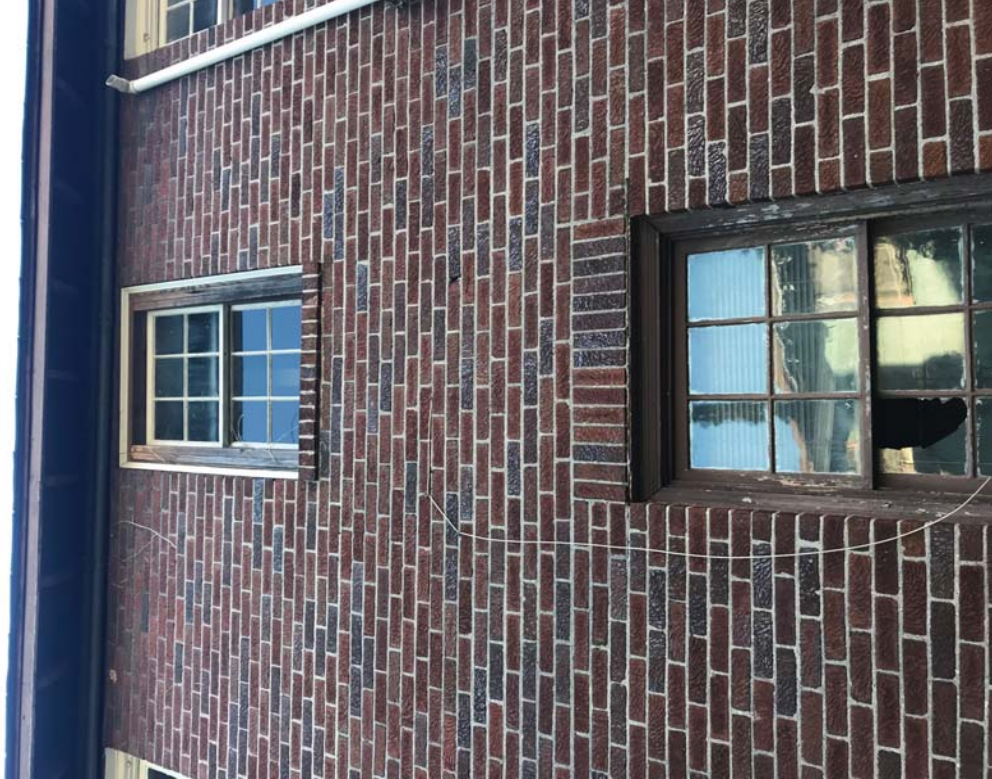
Photo 11 Before

casement latches and cranks are inoperable. Many of the wood windows have substantial rot, both interior and exterior. (Photo 11)

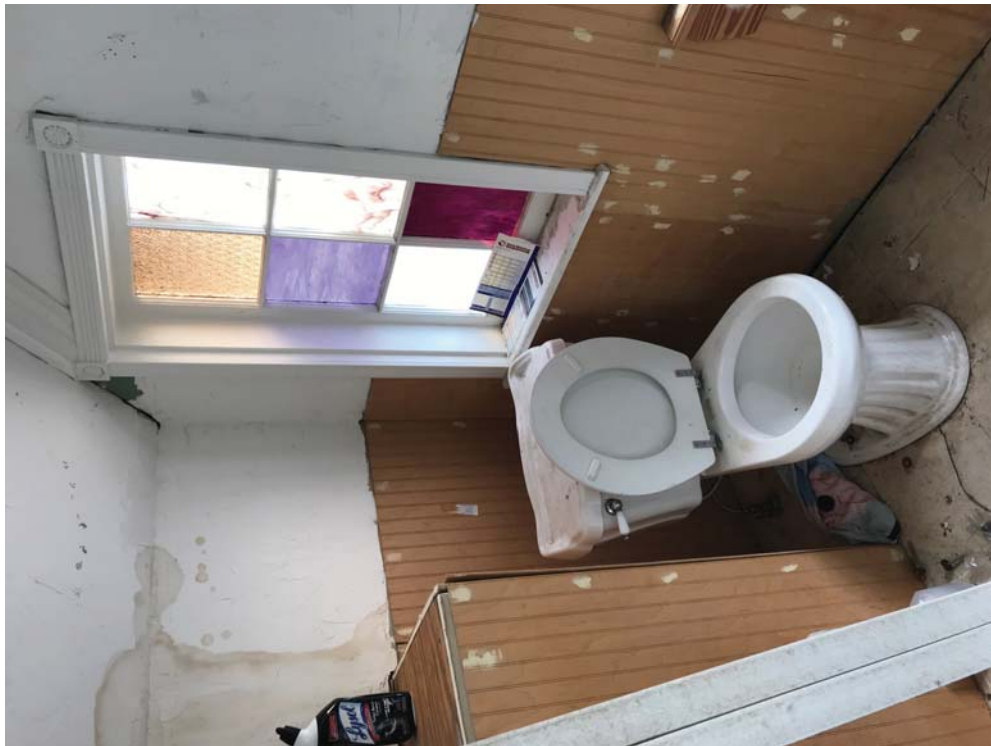
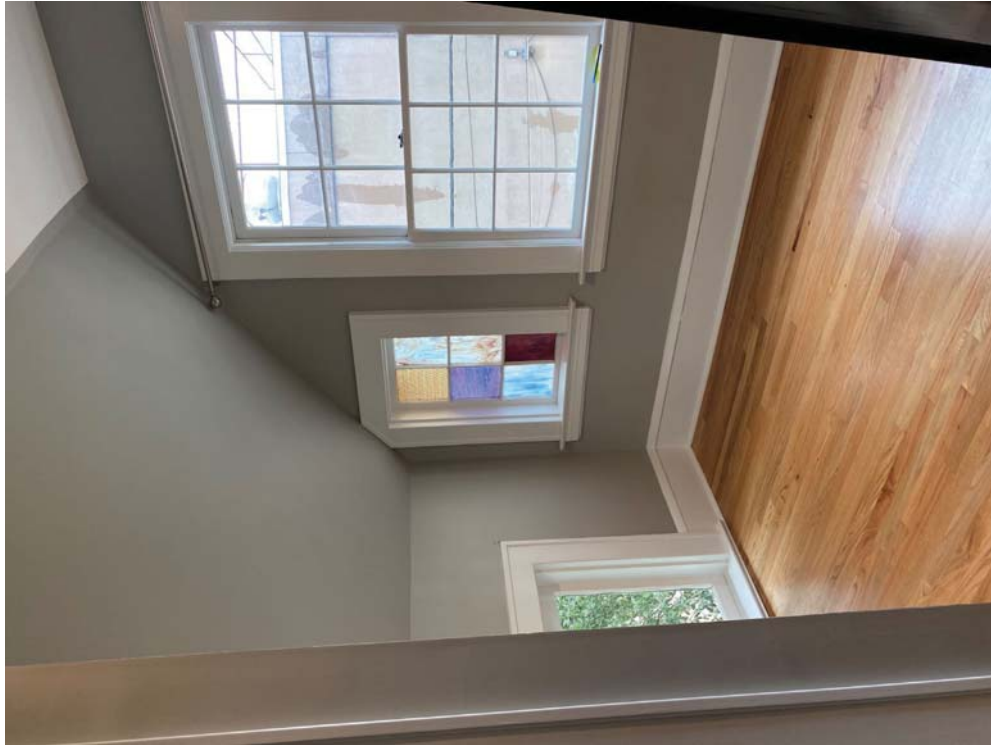
Photo 12 Before

The bathrooms have tile floors. (Photos 12 & 38) Some also have beadboard or tile wainscot.

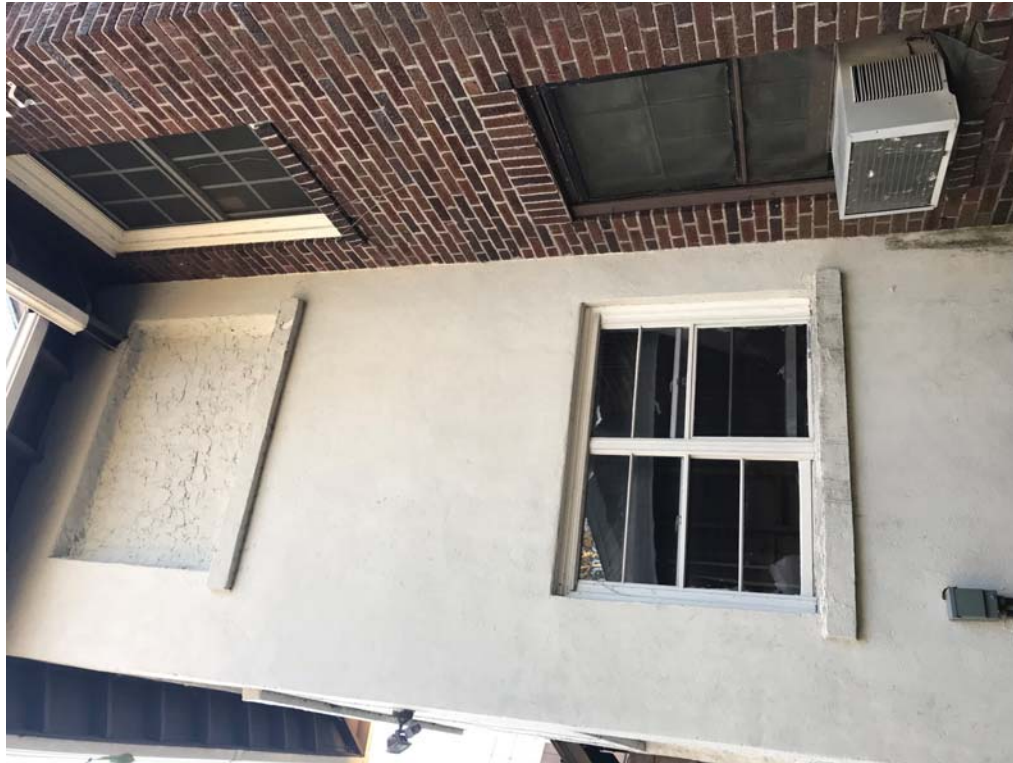
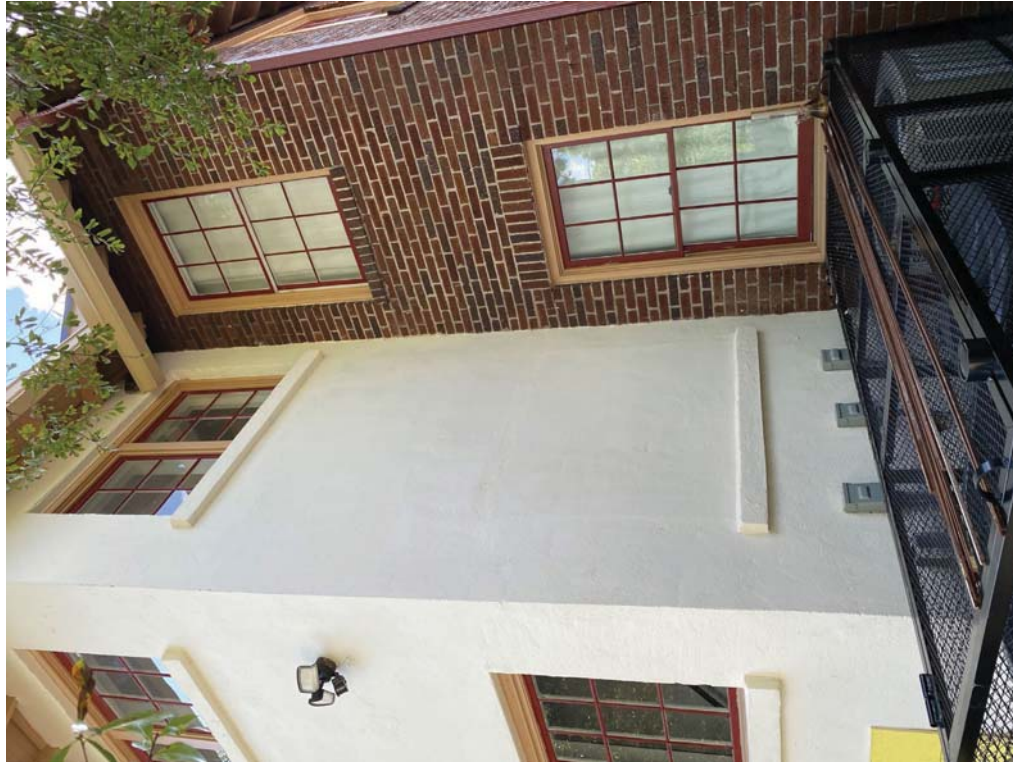
Photo 13 Before

There are no vents or evidence of central air conditioning on the first or third floors. There is a window air conditioning unit in the Bedroom 110. (Photo 13) Condensation from this window unit has damaged the sheathing below the window, as well as the window sill. (Photo 43)

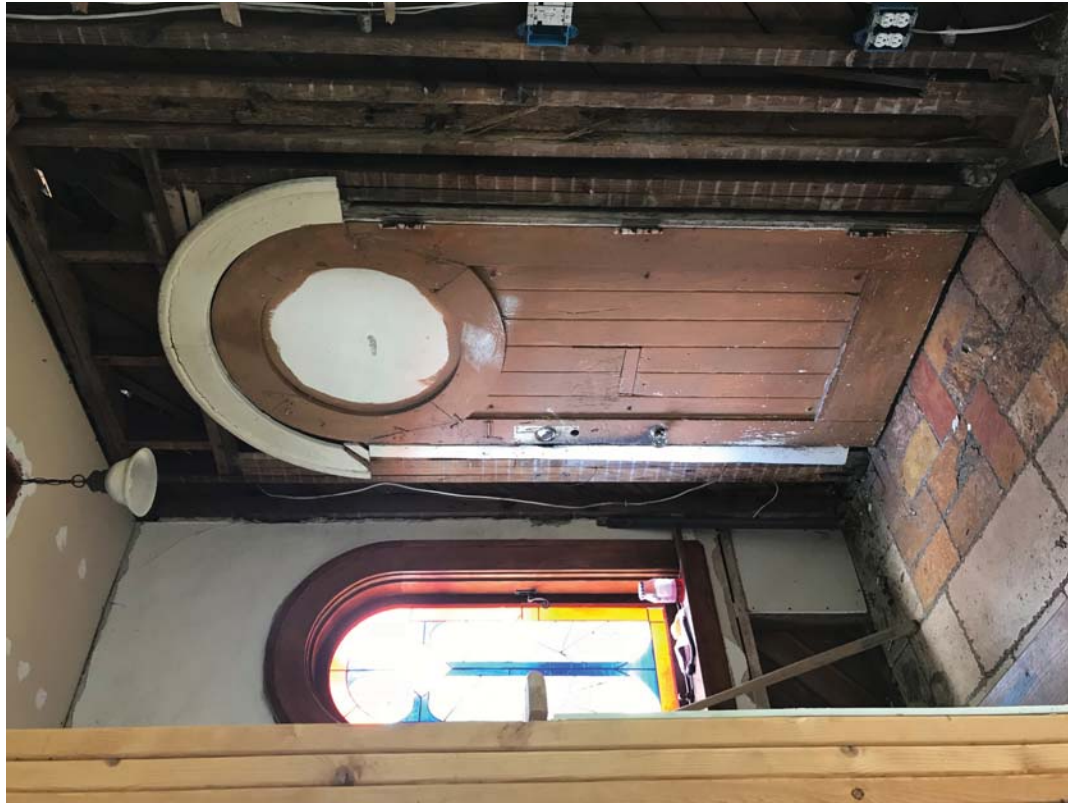
Photo 14 Before

Some of the glazing in the casement windows was replaced with stained glass or covered with film by the previous owner. (Photo 12 & 14)

The front door profile is arched at the top and the door may have previously had a circular window in it. (Photos 14 & 15) The door is severely damaged and appears to be held together in many areas by metal bracing. The hardware that remains is inappropriate, rusted and insecure. The interior trim is damaged and is missing in places. There is a screen door on the outside that is ripped and the frame is damaged.

Existing interior partitions are a mix of gypsum wallboard and plaster finish. The majority of the walls are extremely damaged and many are bare to the studs. (Photo 14) There are no historic characteristics or details cast into the plaster. There is currently a door from Sunroom 118 to Bedroom 115.

All existing windows shall be repaired. Broken glazing shall be replaced with clear uninsulated glazing. All window assemblies that are existing to remain shall be sanded and painted. All window frames, sills and trim shall be repaired or replaced in kind and to match adjacent windows. All hardware shall be fixed or replaced in kind. All windows shall be properly hung, caulked and painted.

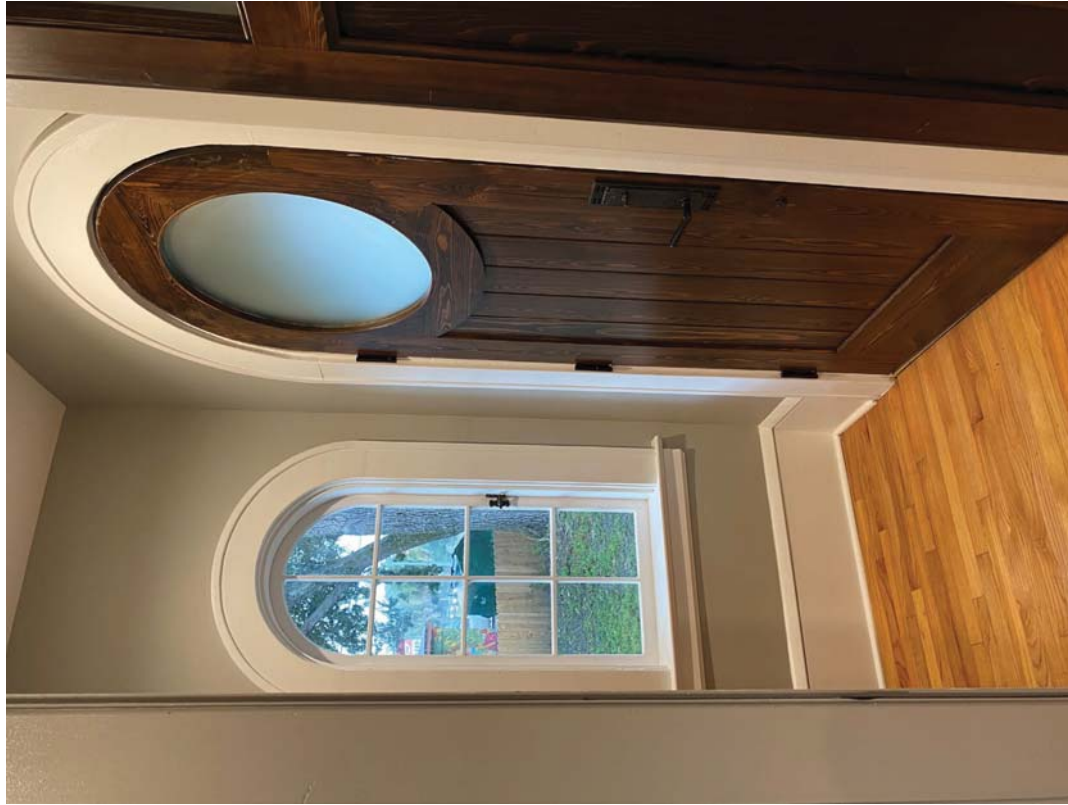
Photo 14 After

The interior lighting has mostly been removed by the previous owner. There is a small pendant at the front door (Photo 14), and a small pendant in the kitchen (Photo 16). There are a pair of sconces installed on either side of the fireplace on the second floor, (Photo 36) and various abandoned light fixtures throughout the house. (Photo 37)

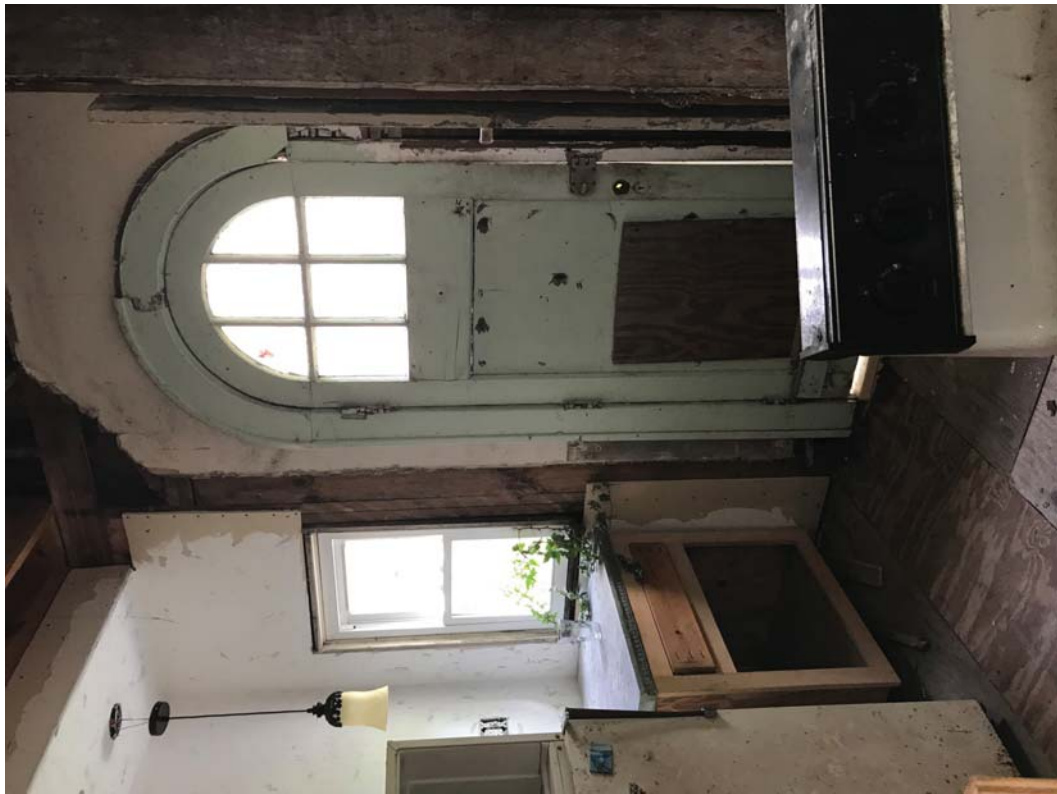
Photo 16 Before

The door on the East elevation also has an arched top. (Photos 16 & 17) This is a solid wood door with six small lights at the top. Much of the hardware is damaged or missing. This door appears to have been poorly repaired by a previous owner and is missing trim and hardware in places.

The flooring throughout is wood, excluding the restrooms. In some places, the finished floor is missing completely and the wood floor joists are temporarily covered in plywood. (Photo 16 & 39)

The front door on the South elevation, and side doors on the East and West elevation are damaged beyond repair. They shall be rebuilt to match the original intent. Hardware shall be cleaned or replaced as necessary, and shall be historically sympathetic. All damaged or missing glazing shall be replaced with uninsulated glazing. The non-functioning opening to the left of the back door shall be filled in with new brick.

The existing wood flooring shall be sanded and cleaned where possible. Where flooring is missing or damaged beyond repair, new wood floors shall be installed to match existing.

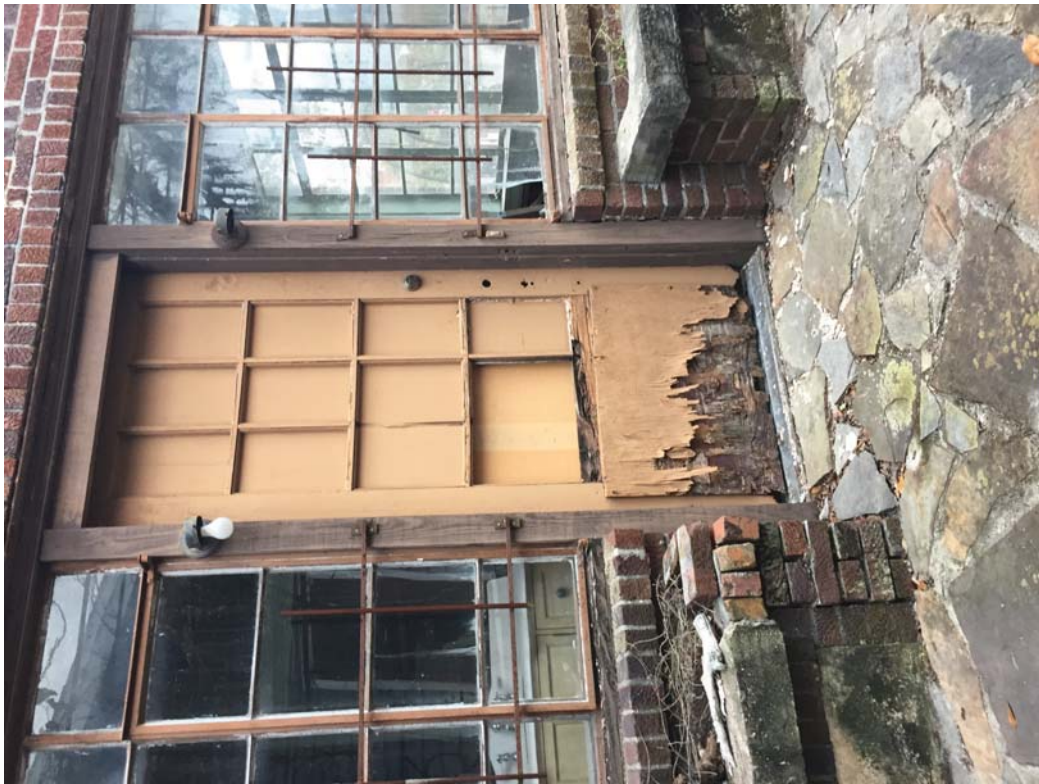
Photo 18 Before

The door to the patio on the West elevation is also severely damaged. (Photo 18 & 19) The bottom of the door is rotten and the glazing is missing, or has been painted over. This door also was patched with wood panels by the previous owner.

Sconces at the South and West entrances shall be cleaned and refurbished where possible. Where these exterior light fixtures are beyond repair, they shall be replaced in-kind. New low profile site lighting shall be installed in the rear parking area for safety. (See details A10.5)

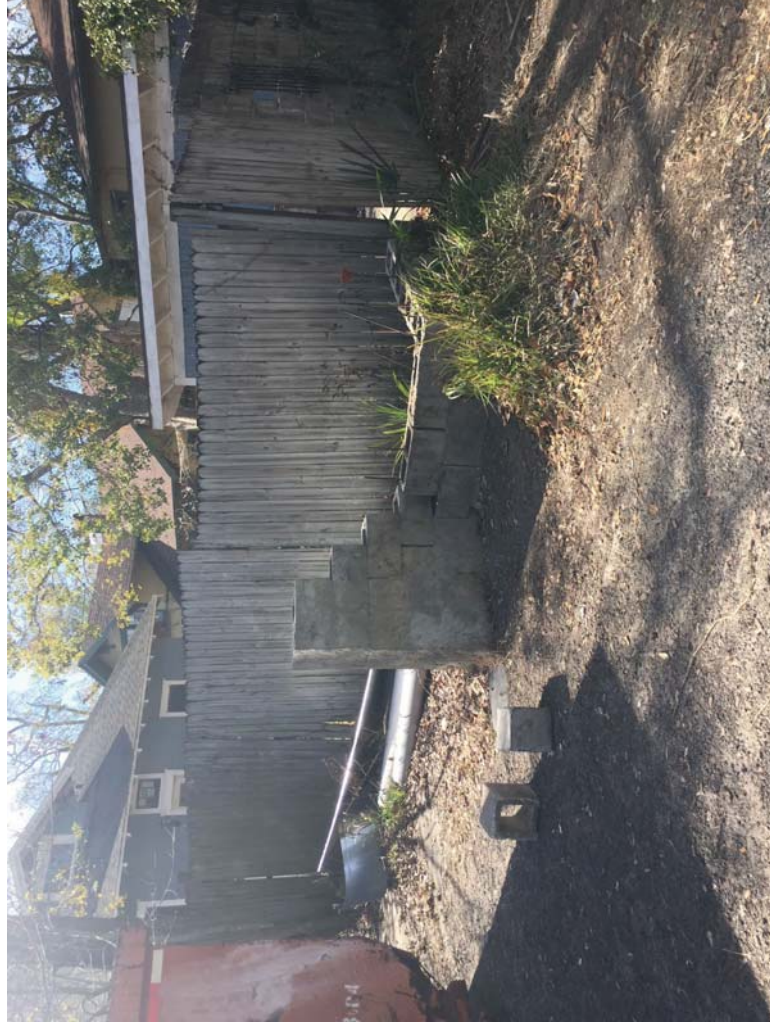
Photo 29 Before

Photos 29 & 30 depict the existing condition of the northeast property line. The left side of Photo 30 shows the stucco veneered existing fence pier. The right side of that photo shows where the previous owner started building a concrete block wall to match up with the opposite pier. This was poorly built and shall be removed. Sheet A10 details the new masonry pier to be constructed and an electric bi-fold gate shall be installed for security.

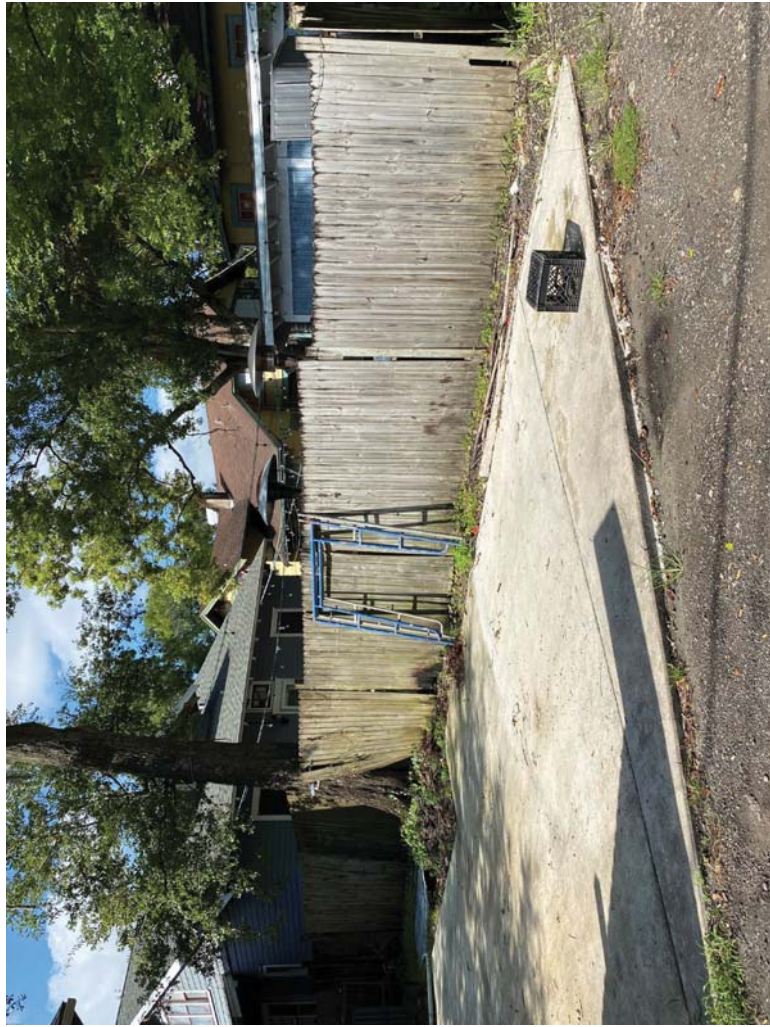
Photo 29 After

A previous owner installed the existing fencing so it is not original to the property. A previous owner also started building an extension of the fence, visible in photos 29 & 30.

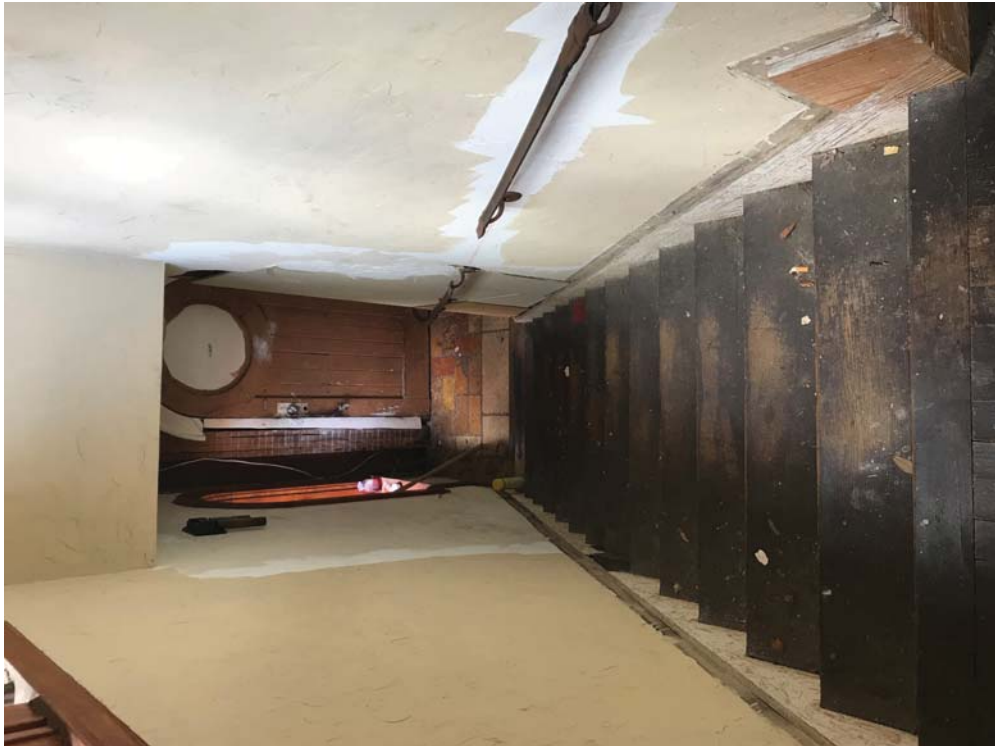
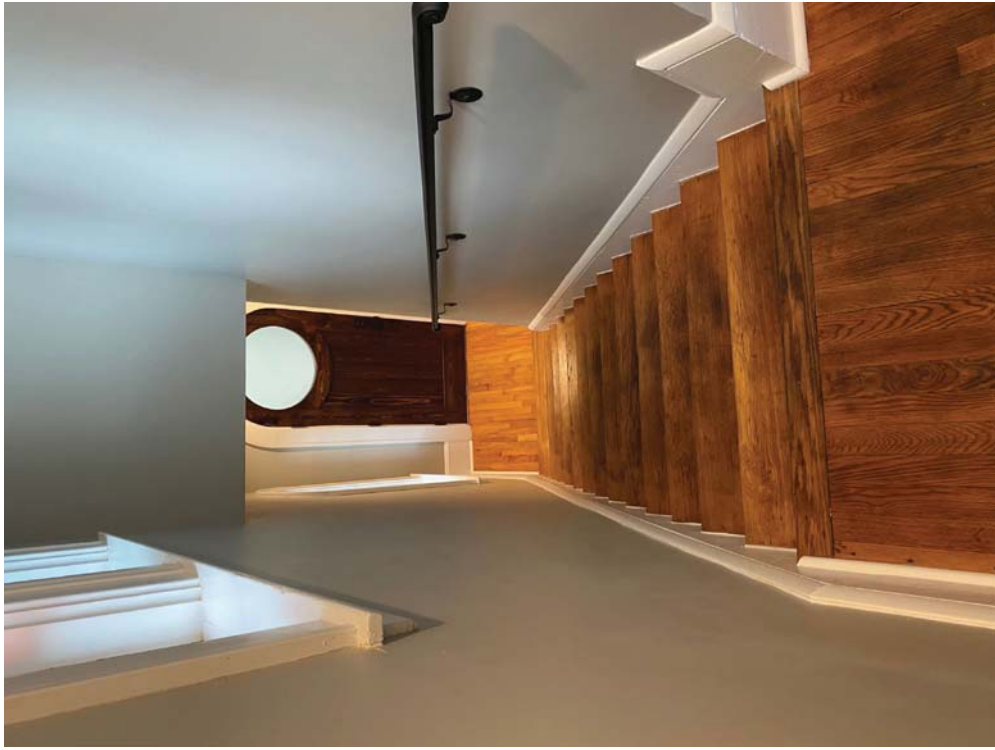
Photo 31 Before

Primary stairs (Stair 1) adjacent to the front door are in good condition. The treads are stained wood, and the risers are painted. The paint is chipping and the stain is worn in areas. The existing metal handrail is not original and is also not continuous. (Photos 31 & 32)

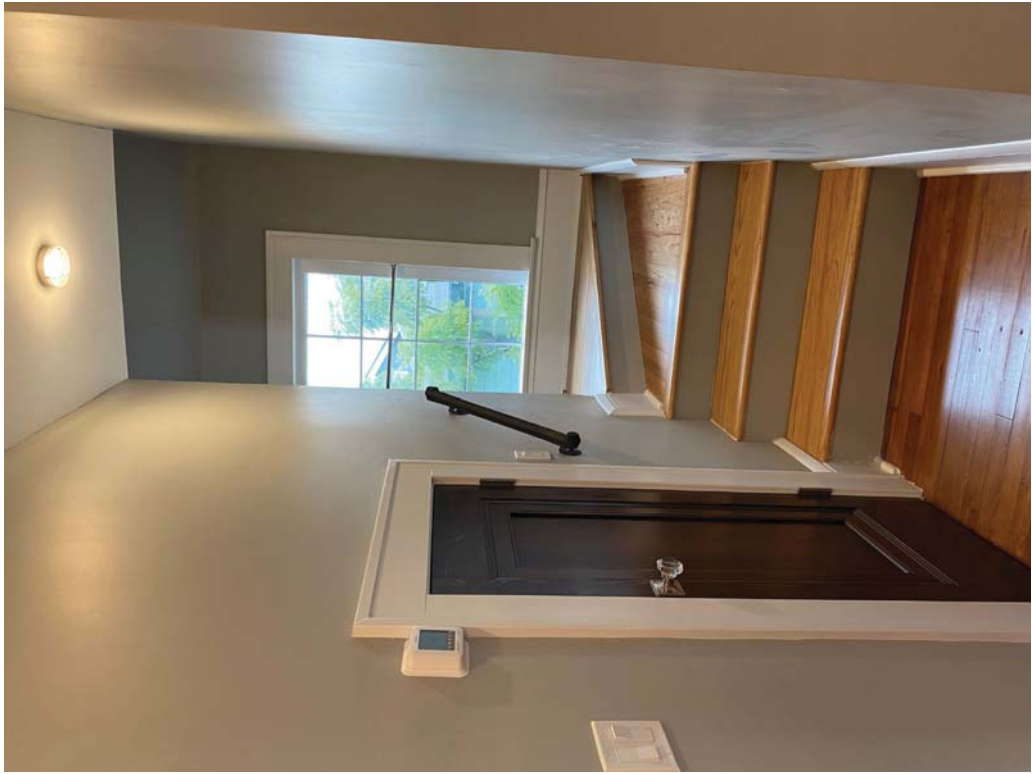
Photo 33 After

Existing stairs from the second floor to the third floor (Stair 3) are also in good condition. The existing treads and risers are unfinished wood. There is not a handrail for these stairs currently. (Photos 33 & 34)

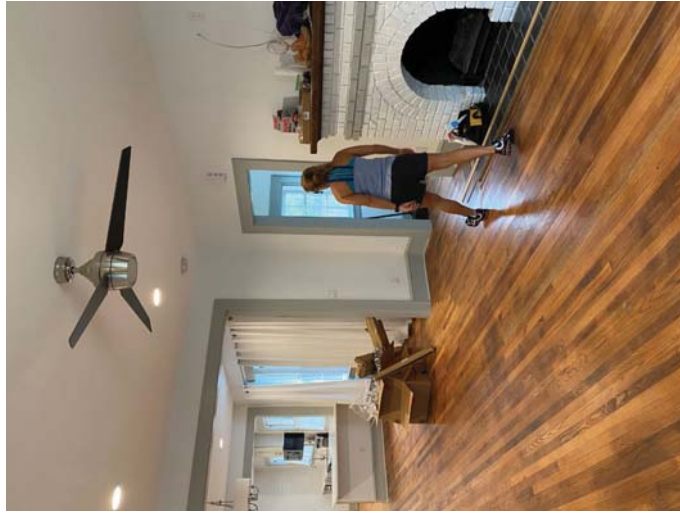
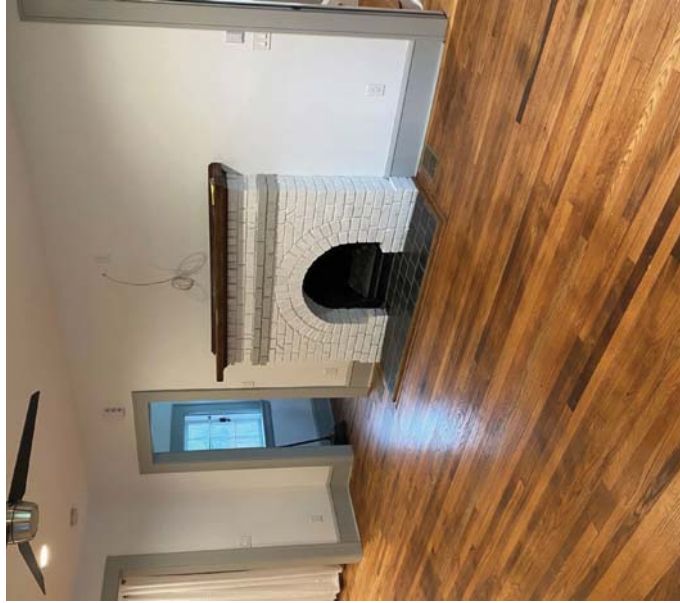
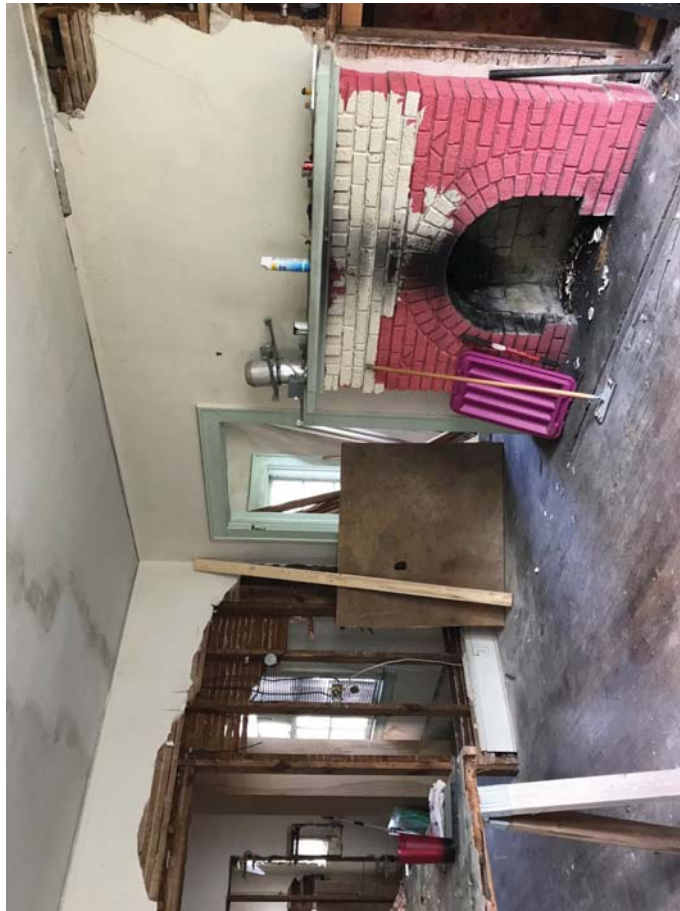
Photo 35 Before

Both fireplaces have a small stone tile hearth. (Photos 35 & 36) The downstairs fireplace is faced in brick that has been painted many times. The second floor fire place is faced in faux stone with heavy wood details that are not believed to be historic.

Much of the interior trim has been removed or replaced. The first floor trim is shown in photo 44 and some areas have a simple picture rail rather than crown moulding (Photos 44 & 35). All trim throughout the house will be built to match the trim shown in these photos.

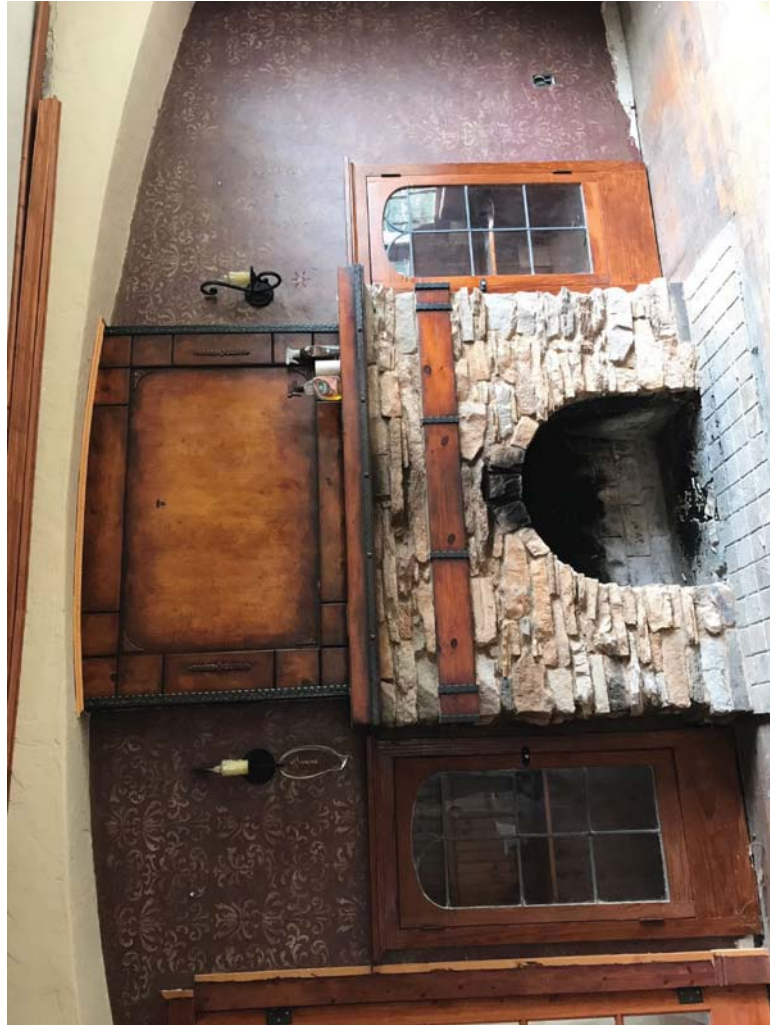
Photo 36 Before

The ceilings throughout are gypsum wallboard, which is damaged in many places or is missing entirely. (Photo 39) There is currently an arched soffit over the fireplace on the second floor that is not believed to be historic. (Photo 36)

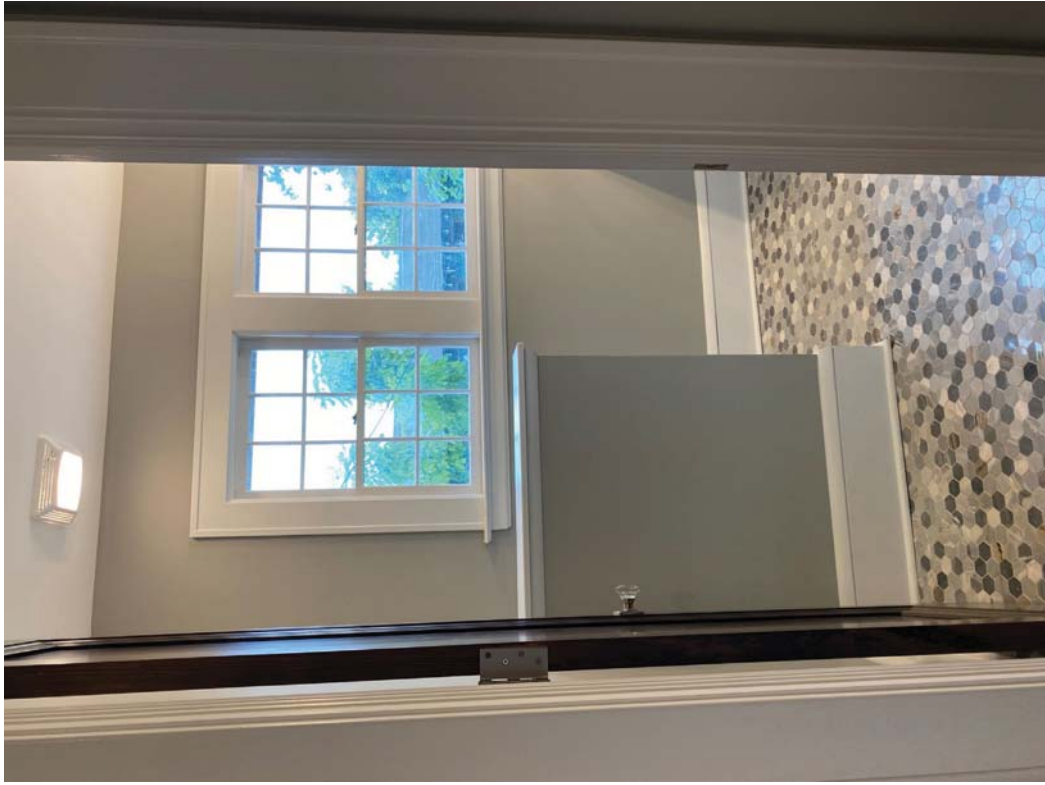
Photo 37 After

There are many different trim and casing details throughout the house. There are also many places that are missing casing or trim entirely. (Photo 37)

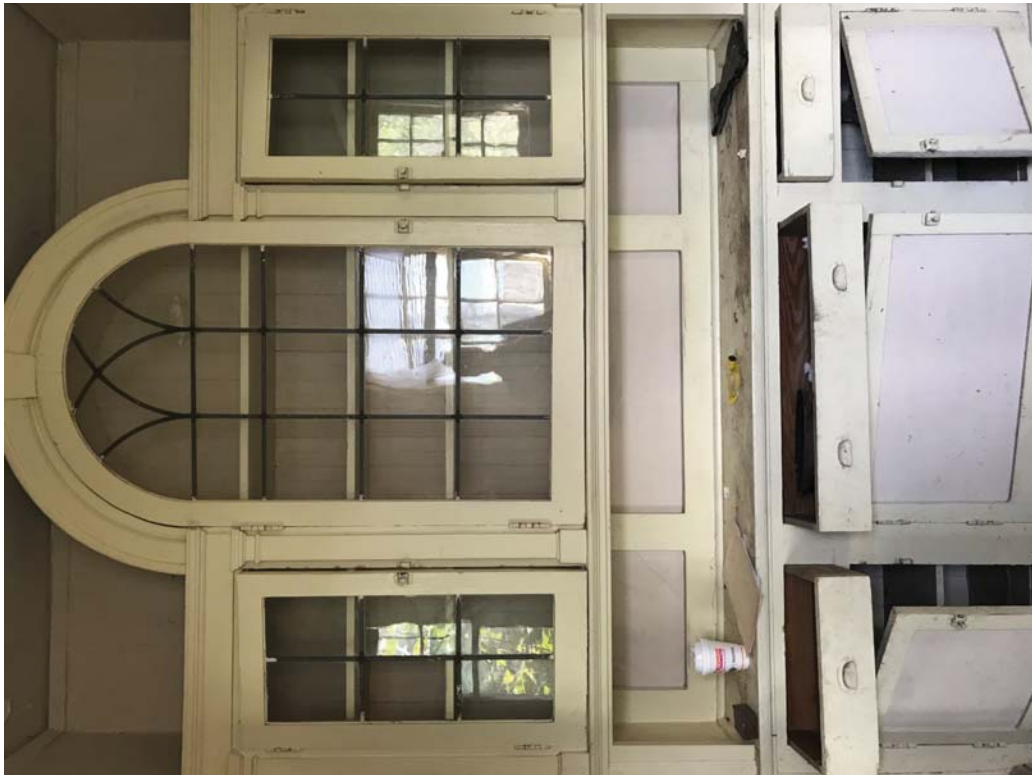
Photo 40 Before

Describe existing feature and its condition:  
There are two cabinets that are believed to be historic and original to the building. One is currently installed on the first floor. (Photo 40) This cabinet is in relatively good condition and includes an upper cabinet with a glass doors and wood shelves. It is missing some glazing and the hardware and drawer slides are damaged.

The existing cabinet in Dining Room 104 shall be repaired, sanded, cleaned and painted. The missing glazing shall be replaced in-kind. All hardware shall be cleaned and adjusted where possible. Any missing or damaged hardware shall be replaced in-kind. The cabinet shall be relocated to Dining Room 104 to best serve the new floor plan.
