**HISTORIC PRESERVATION PROPERTY TAX EXEMPTION APPLICATION  
PART I--PRECONSTRUCTION APPLICATION**

Address of property: 2739 Post Street

Name of historic district: Riverside National Register District

Existing Conditions at:  
**2739 Post Street**  
Jacksonville, Florida

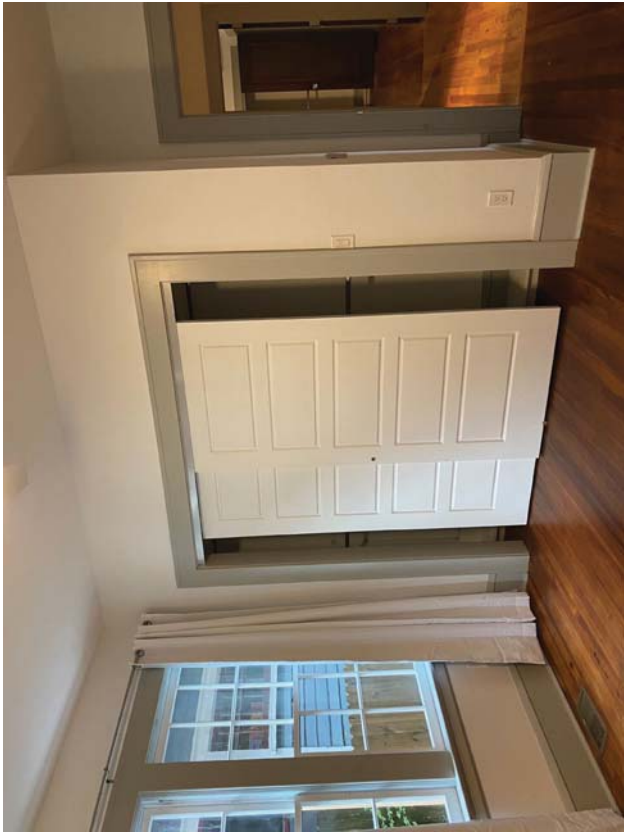
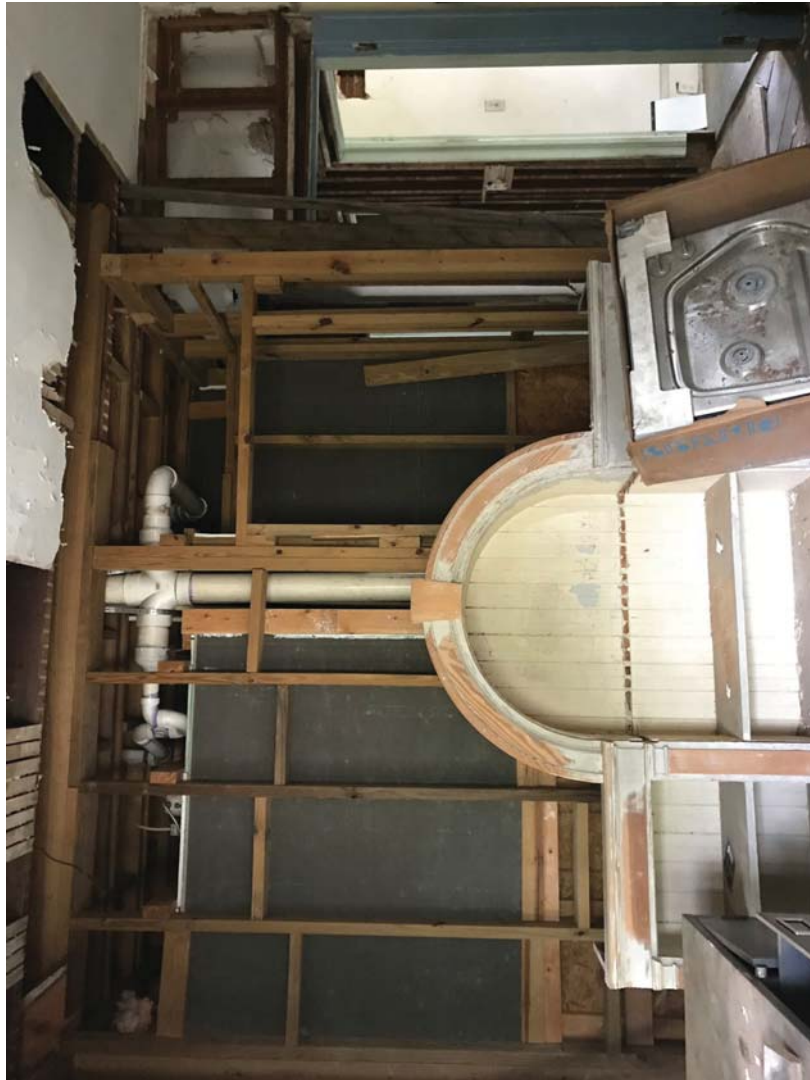
Photo 41 Before

The other cabinet has been uninstalled and is sitting on the floor in Bedroom 115. (Photos 41 & 42) This cabinet does not have any glazing or hardware, but has similar wood detailing to the other cabinet. The cabinet on the floor in Bedroom 115 does not have a lower cabinet  
Photograph Number: 40-42 Drawing Number: A1, A2 & A10

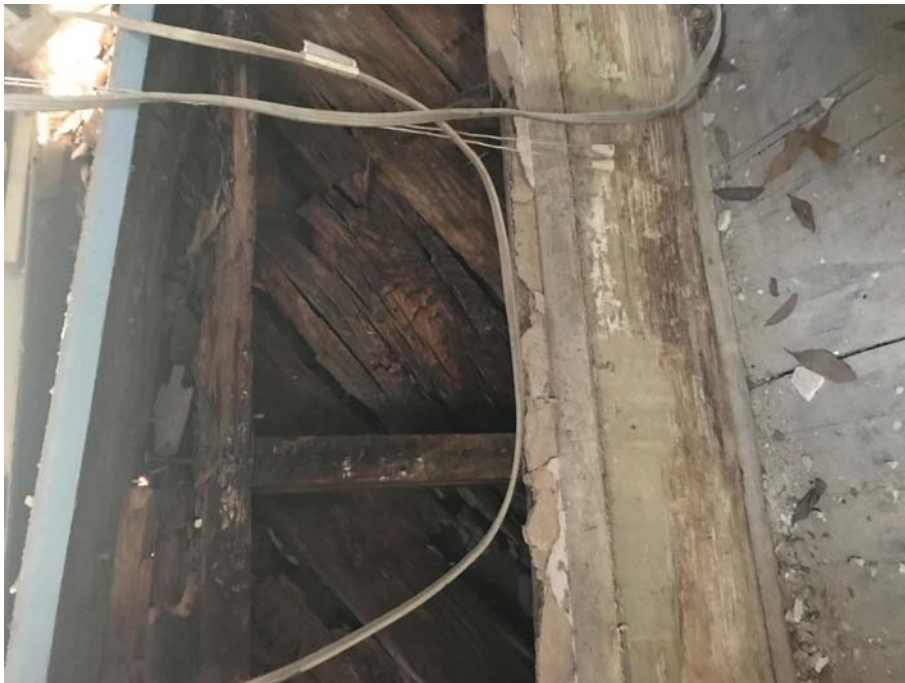
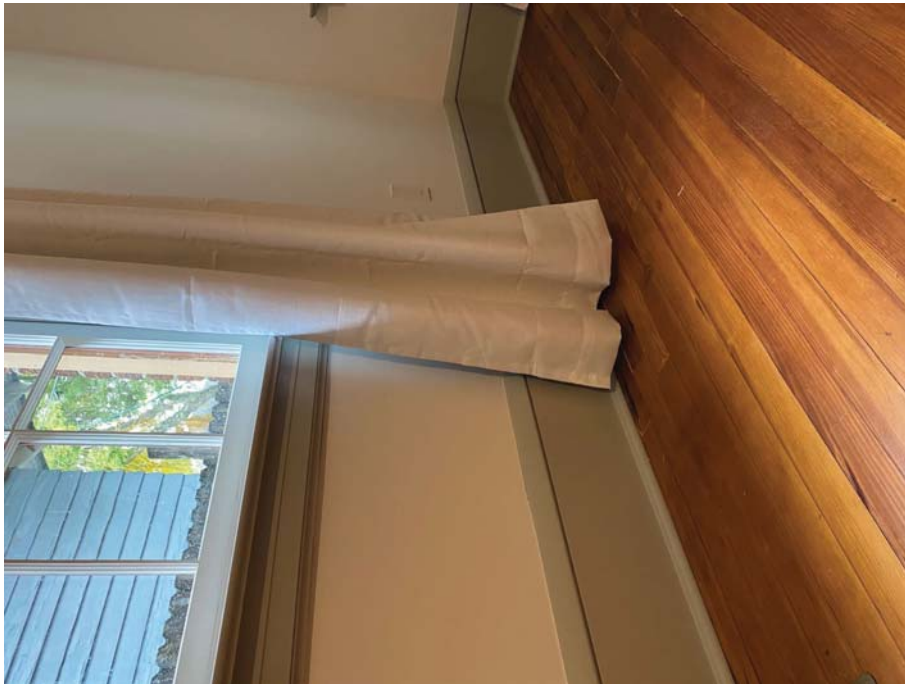
Photo 43 Before

There are no vents or evidence of central air conditioning on the first or third floors. There is a window air conditioning unit in the Bedroom 110. (Photo 13) Condensation from this window unit has damaged the sheathing below the window, as well as the window sill. (Photo 43)
