BAYMEADOWS SOUTHEASTERN PORTION OF THE MASTER LAKE SYSTEM CRITICAL DRAINAGE COMPONENTS AND OPERATION AND MAINTENANCE GUIDELINES

BAYMEADOWS SITES
 FOR
 D.R. HORTON, INC. - JACKSONVILLE

SOUTHEAST CORNER DRAINAGE MAINTENANCE PLAN

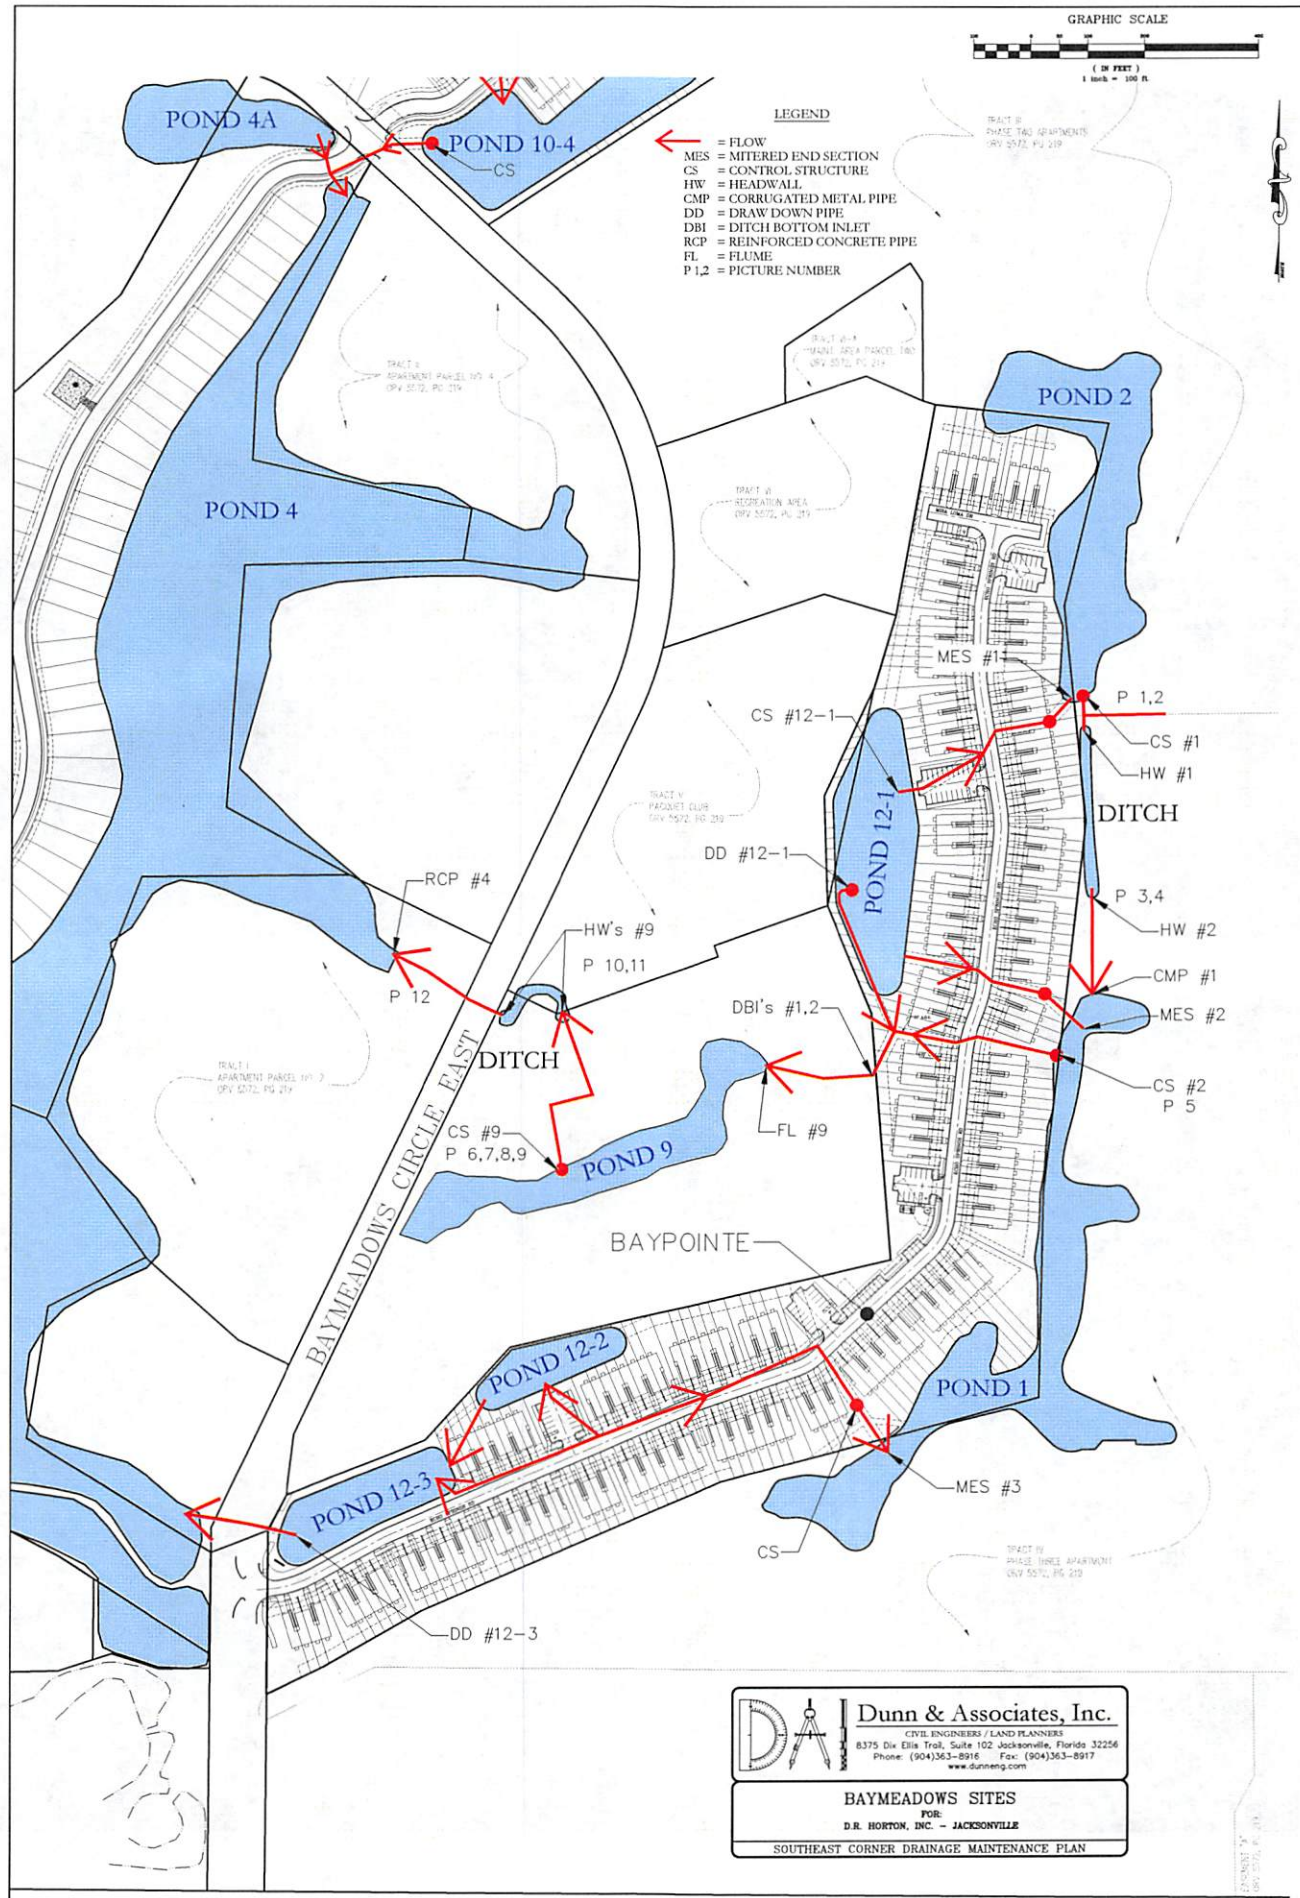
- MES #1, Keep the Baypointe inflow MES clear of vegetative growth with monthly inspections
- CS #1, Headwall / Weir (Photos 1 and 2) is not functioning. Structure needs to be retrofitted to original design including reconnecting structure to discharge pipe. This connection is offsite on private property and should be rebuilt. Pond 2 to the north appears to have reasonable freeboard; however, drainage into and around pond 2 from the north and east has not been evaluated as part of this effort.
- HW #1, Culvert is silted in. Recommend removing silt from culvert and ditch to allow for positive discharge.
- Ditch is silted in. The excess debris and vegetation should be removed.
- HW #2 (Photo 3) needs to be inspected for silt and debris. Any blockage needs to be removed.
- CS #1, the ditch and HW #2 needs monthly inspections and debris removal and corrective work performed, as needed.

- CMP #1, has no end treatment and has been crushed (Photo 4) . This culvert is offsite on private property and needs to be replaced along with a proper end treatment constructed.

- MES #2, Keep the Baypointe inflow MES clear of vegetative growth with monthly inspections.
- CS #2, The current structure has a grate elevation at 25.0 and had 5 – inches water above the grate during our inspection (Photo 5). The CS will be modified to include a 3' wide weir at elevation 24 or possibly 23.5 to increase storage in pond 1. The pre-existing pipe crossing the golf course was at invert elevation 24.8 and silted in to elevation 25. The lowered NWL has been discussed with Elmedin Strikovic with GoldOller.

- MES #3, Keep the Baypointe inflow MES clear of vegetative growth with monthly inspections.
- CMP #1 replacement into pond 1 needs monthly inspections and debris removal and corrective work performed, as needed.

- DD #12-1 and CS #12-1, Keep drawdown and control structure clear of vegetation with monthly inspections. Excavate 12- inches below bleeddown as needed to ensure proper function.
- DBI 1 and 2, Keep surrounding area mowed and throats to DBIs clear.
