BAYMEADOWS SOUTHEASTERN PORTION OF THE MASTER LAKE SYSTEM CRITICAL DRAINAGE COMPONENTS AND OPERATION AND MAINTENANCE GUIDELINES

BAYMEADOWS SITES
 FOR
 D.R. HORTON, INC. - JACKSONVILLE

SOUTHEAST CORNER DRAINAGE MAINTENANCE PLAN

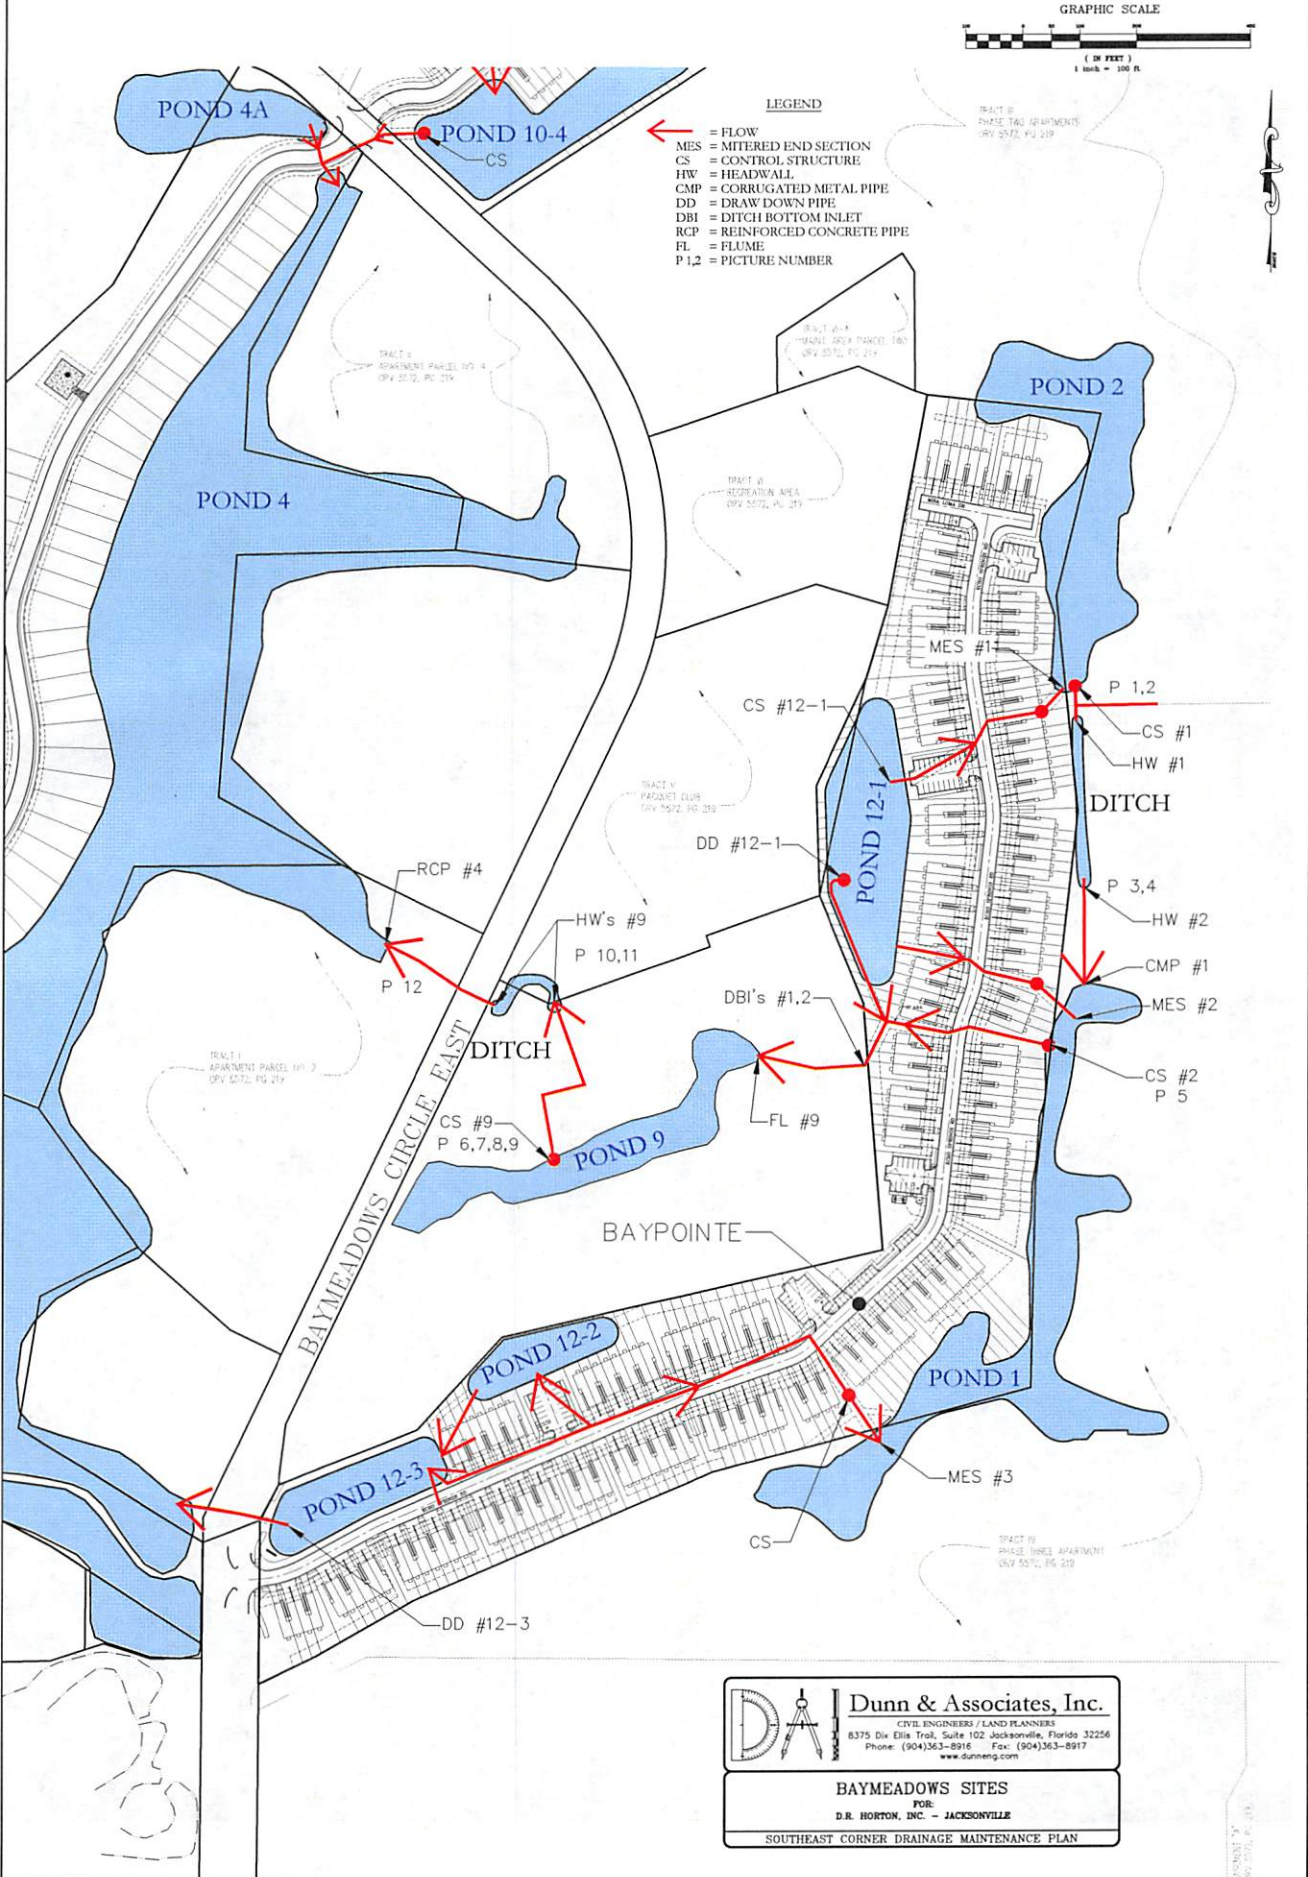
- MES #1, Keep the Baypointe inflow MES clear of vegetative growth with monthly inspections
- CS #1, Headwall / Weir (Photos 1 and 2) is not functioning. Structure needs to be retrofitted to original design including reconnecting structure to discharge pipe. This connection is offsite on private property and should be rebuilt. Pond 2 to the north appears to have reasonable freeboard; however, drainage into and around pond 2 from the north and east has not been evaluated as part of this effort.
- HW #1, Culvert is silted in. Recommend removing silt from culvert and ditch to allow for positive discharge.
- Ditch is silted in. The excess debris and vegetation should be removed.
- HW #2 (Photo 3) needs to be inspected for silt and debris. Any blockage needs to be removed.
- CS #1, the ditch and HW #2 needs monthly inspections and debris removal and corrective work performed, as needed.

- CMP #1, has no end treatment and has been crushed (Photo 4) . This culvert is offsite on private property and needs to be replaced along with a proper end treatment constructed.

- MES #2, Keep the Baypointe inflow MES clear of vegetative growth with monthly inspections.
- CS #2, The current structure has a grate elevation at 25.0 and had 5 – inches water above the grate during our inspection (Photo 5). The CS will be modified to include a 3' wide weir at elevation 24 or possibly 23.5 to increase storage in pond 1. The pre-existing pipe crossing the golf course was at invert elevation 24.8 and silted in to elevation 25. The lowered NWL has been discussed with Elmedin Strikovic with GoldOller.

- DD #12-1 and CS #12-1, Keep drawdown and control structure clear of vegetation with monthly inspections. Excavate 12- inches below bleeddown as needed to ensure proper function.
- DBI 1 and 2, Keep surrounding area mowed and throats to DBIs clear.

- MES #3, Keep the Baypointe inflow MES clear of vegetative growth with monthly inspections.
- CMP #1 replacement into pond 1 needs monthly inspections and debris removal and corrective work performed, as needed.
