Historic Stanton Repairs

521 W Ashley

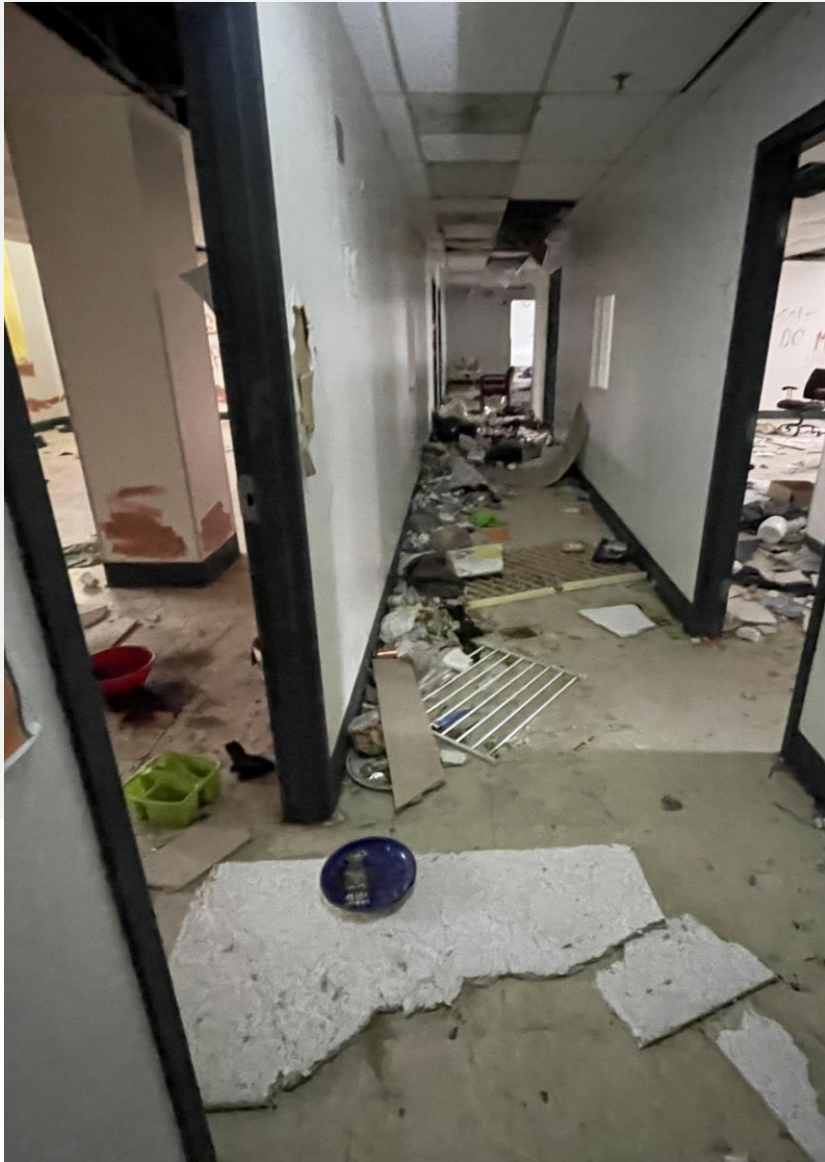
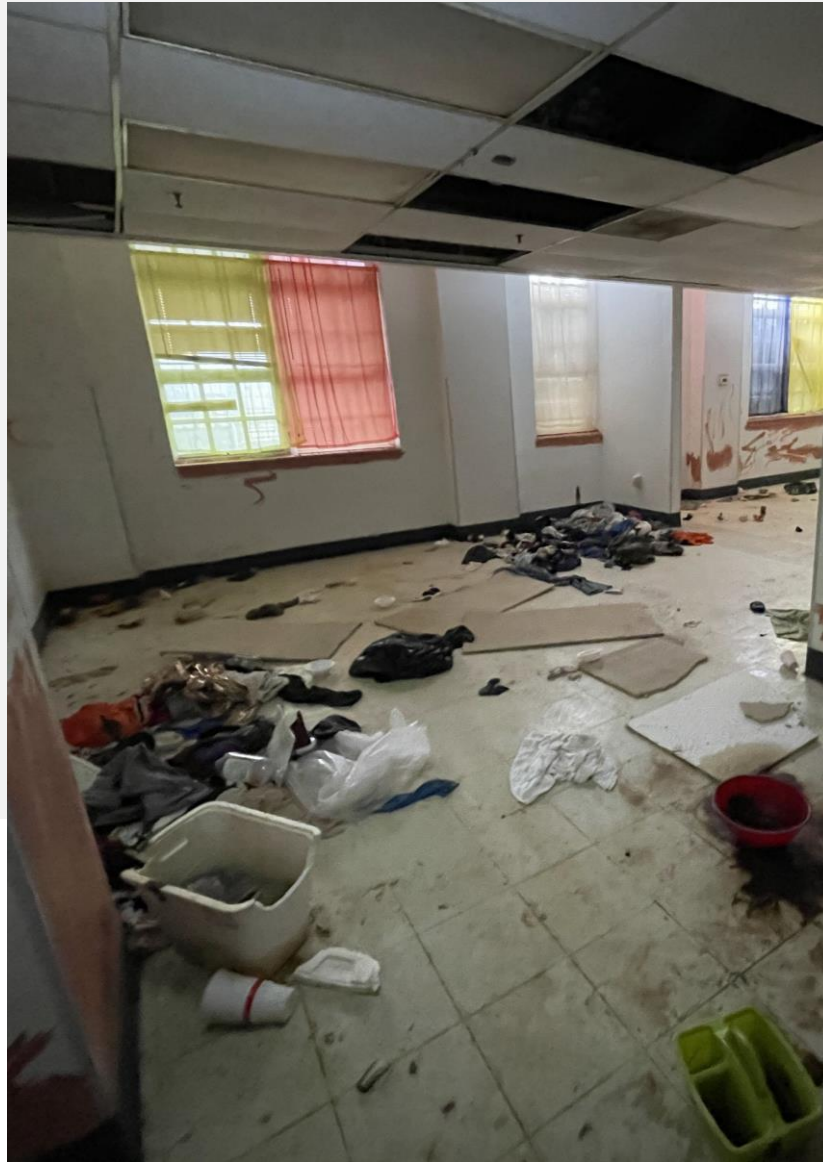
1st Floor

First Floor Demo

- The first floor is the only floor not previously demo'ed. It housed a tenant as recently as 3 years ago. All acoustic ceiling, lighting, wires, conduit, duct work, trash, etc. will be removed

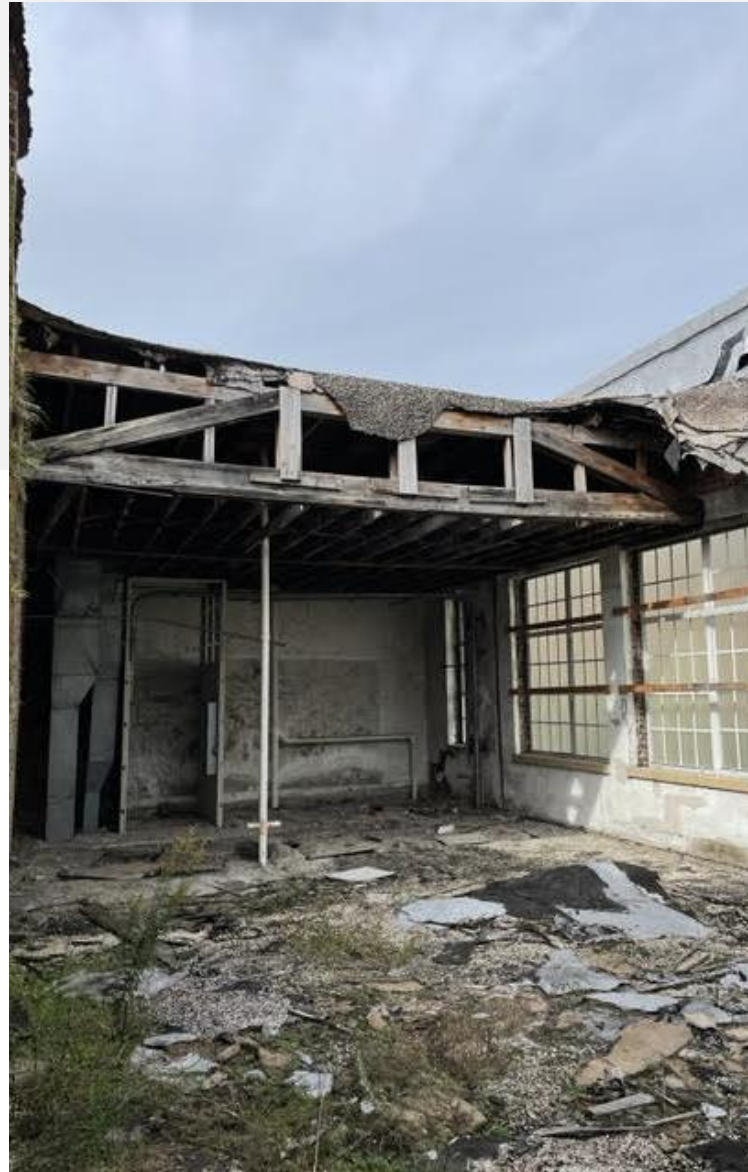
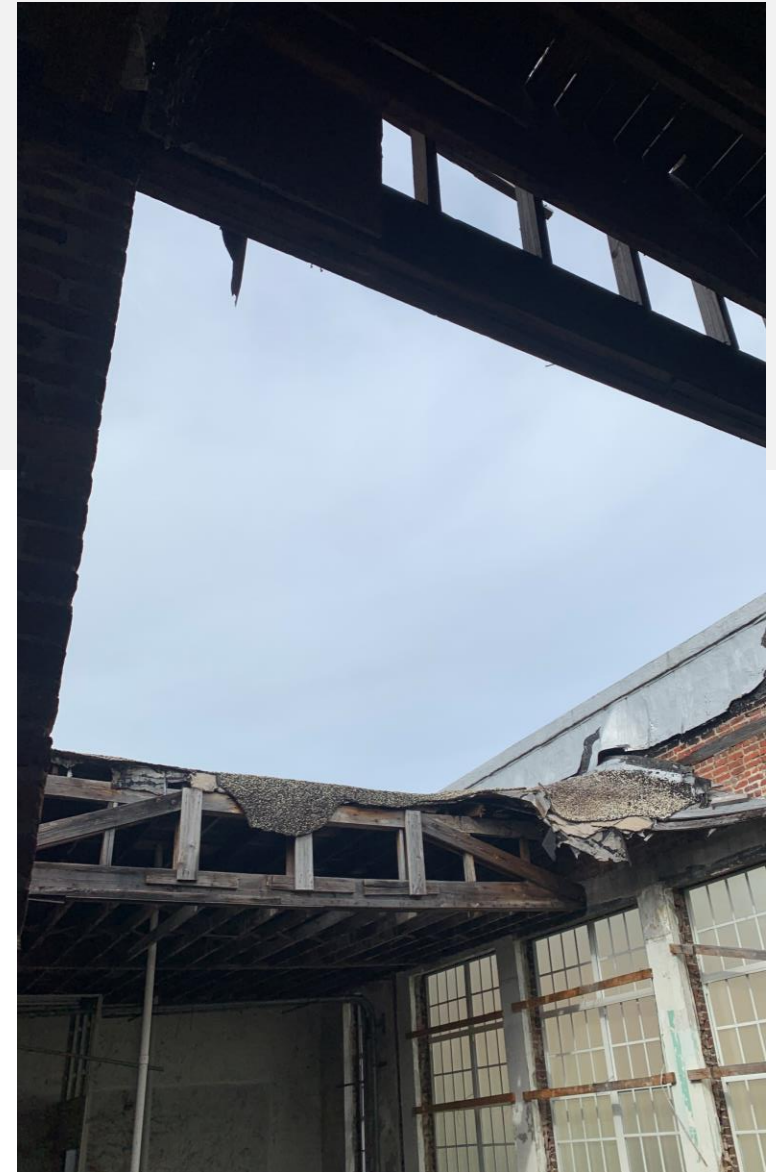
Floor under roof opening

- There is concern about the stability of the floor below the open roof. See hole already created by wash out of rain.
